HP LaserJet Managed Flow MFP E82540-E82560 series and HP LaserJet Managed MFP E82540-E82560 series - Control panel message document (CPMD)

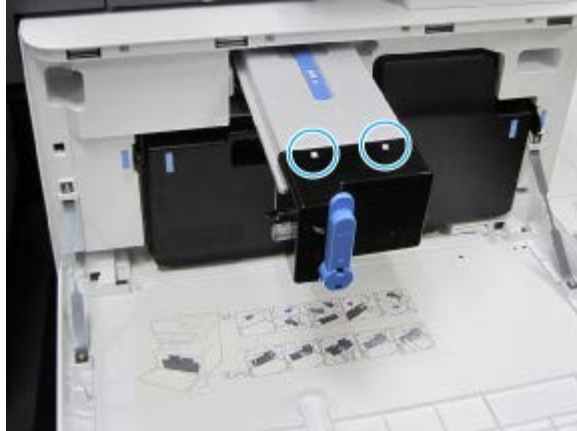
1. Open the front cover. Check if the toner cartridge is installed.
2. Remove and reinstall the toner cartridge and ensure that the latch clicks closed.
3. Check if the toner cartridge or image unit is installed correctly.
 - a. If the cartridge comes out automatically, check the toner cartridge latching hook.

- b. If the toner cartridge hook is damaged, replace the toner cartridge.
Part number: X3A74-67901
4. Check if the CRUM harness of the toner cartridge is connected correctly.

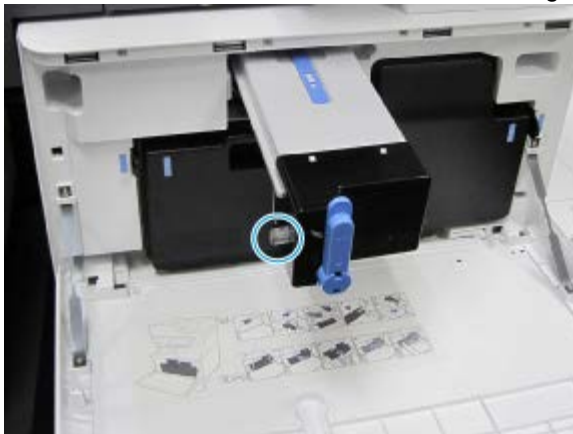
- a. Check if the CRUM connector of the toner cartridge is broken or assembled abnormally.
 - b. If the CRUM connector is damaged or defective, replace the toner cartridge.
Part number: X3A74-67901

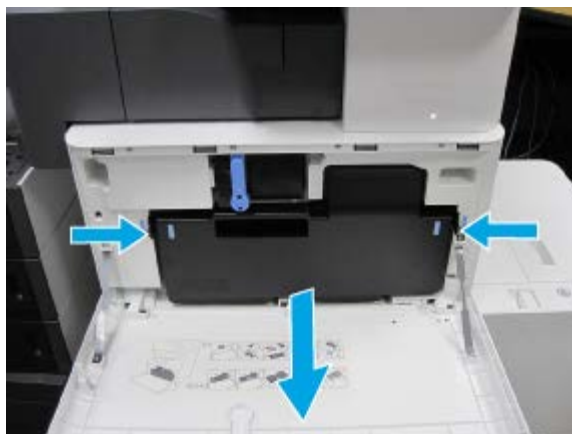
1. Open the front cover. Remove the toner collection unit.
2. Remove and reinstall the imaging drum.

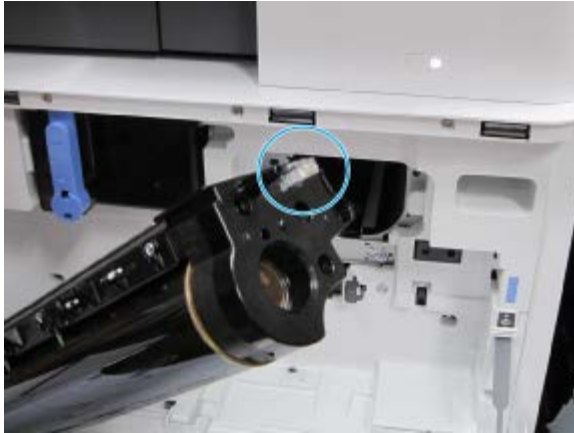
4. Check if the CRUM harness of the imaging drum unit is connected correctly.

- a. Check if the CRUM connector of the drum unit is broken or is not seated correctly.
- b. +If the CRUM connector is damaged or defective, replace the imaging drum unit.
Part number: X3A74-67902

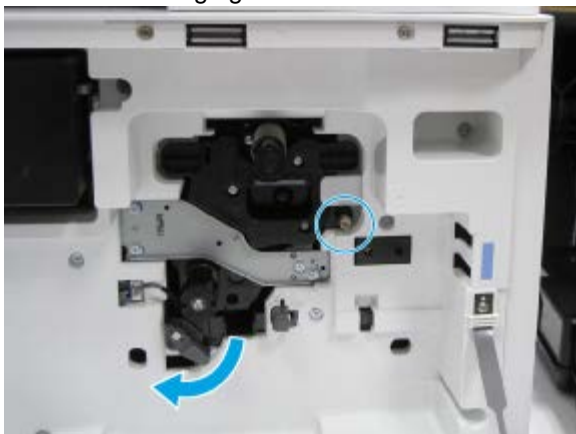
2. Remove the imaging drum unit.

- a. Open the right side door.
 - b. Loosen the thumb screw.
 - c. Disengage the locking lever.
 - d. Slide the imaging drum unit out.
3. If it is at the end of life, replace the imaging drum unit and developer with a new one.
Part number: X3A74-67902

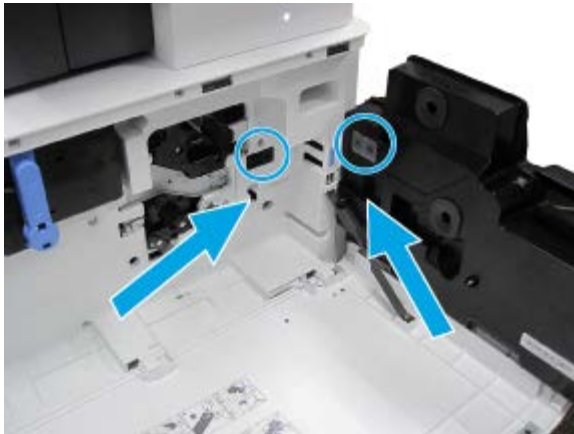
4. Check the toner collection sensor and sensor fin for damage. If the fin on the TCU is damaged replace the TCU.
Part number: SAM-JC96-11638A

1: TCU sensors and fin

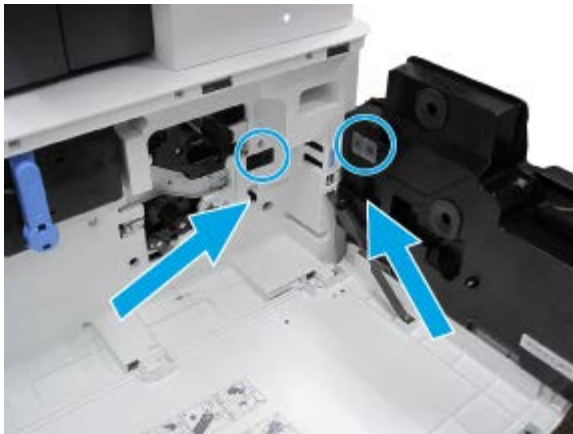
4. Check the toner collection sensor and sensor fin for damage. If the fin on the TCU is damaged replace the TCU.
Part number: SAM-JC96-11638A

2: TCU sensors and fin

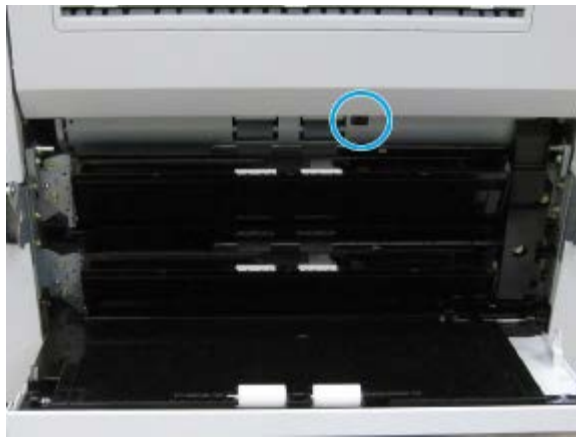
- Service Tools
 - Diagnostics
 - Engine Diagnostics
 - Engine Test Routines
- b. Run test 102-0320, Tray 4 Feed Sensor.
 - c. Trip the tray 4/5 feed sensor as shown in the following image to ensure that it is functioning correctly.

- d. If the sensor test fails, check the wire harness between the tray 4/5 feed sensor and the sheet feeder PCA.
 - e. If the wire harness is good, replace the tray 4/5 feed sensor.
Part number: SAM-0604-001381

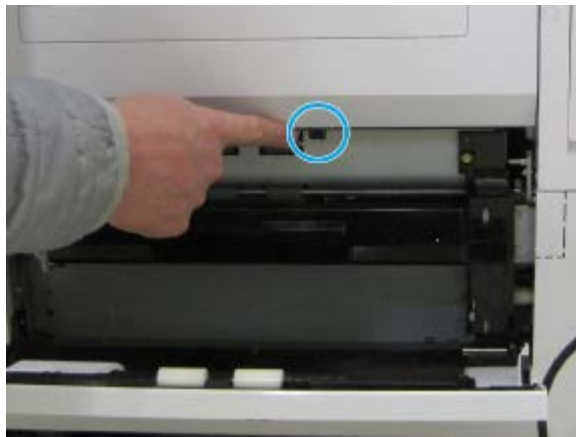
- Service Tools
 - Diagnostics
 - Engine Diagnostics
 - Engine Test Routines
 - b. Run test 102-0320, Tray 4 Feed Sensor.
 - c. Trip the tray 4 feed sensor as shown in the following image to ensure that it is functioning correctly.

- d. If the sensor test fails, check the wire harness between the tray 4 feed sensor and the sheet feeder PCA.
 - e. If the wire harness is good, replace the tray 3/4 feed sensor.
Part number: SAM-0604-001381

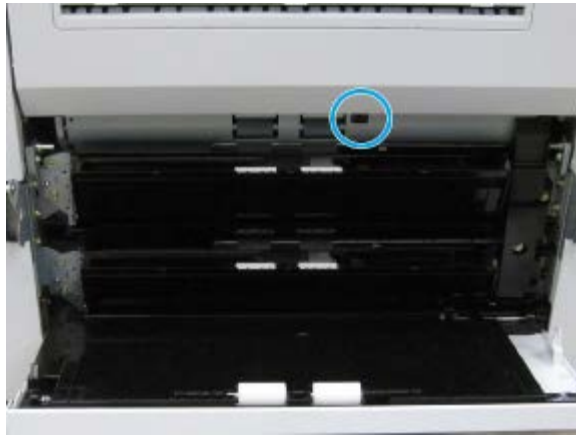
- Service Tools
 - Diagnostics
 - Engine Diagnostics
 - Engine Test Routines
- b. Run test 102-0320, Tray 4 Feed Sensor.
 - c. Trip the tray 4/5 feed sensor as shown in the following image to ensure that it is functioning correctly.

- d. If the sensor test fails, check the wire harness between the tray 4/5 feed sensor and the sheet feeder PCA.
 - e. If the wire harness is good, replace the tray 4/5 feed sensor.
Part number: SAM-0604-001381

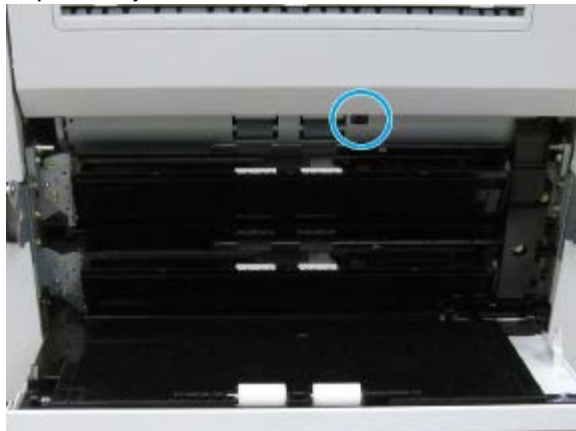
- c. Trip the tray 4/5 feed sensor as shown in the following image to ensure that it is functioning correctly.

- d. If the sensor test fails, check the wire harness between the tray 4/5 feed sensor and the sheet feeder PCA.

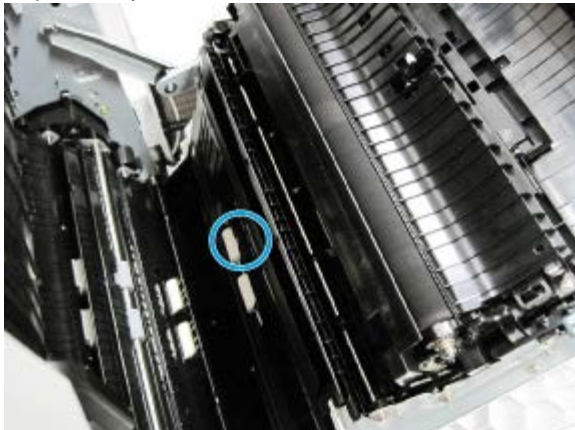
b. Run test 102-0300, Tray 3 Feed Sensor.

c. Trip the tray 3 feed sensor as shown in the following image to ensure that it is functioning correctly.

d. If the sensor test fails, check if the wire harness on the guide-feed assembly is connected correctly.

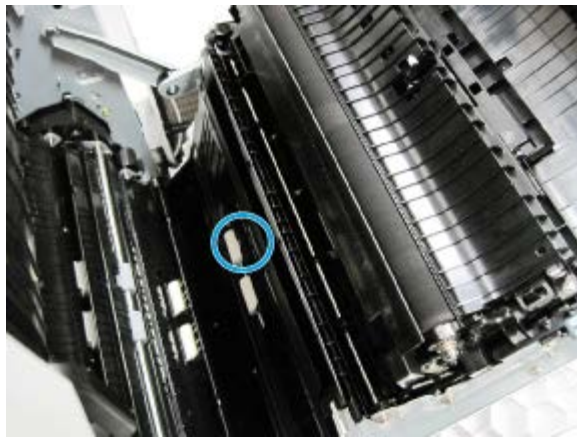
- Service Tools
 - Diagnostics
 - Engine Diagnostics
 - Engine Test Routines
 - b. Run test 102-0300, Tray 3 Feed Sensor.
 - c. Trip the tray 3 feed sensor as shown in the following image to ensure that it is functioning correctly.

- d. If the sensor test fails, check if the wire harness on the guide-feed assembly is connected correctly.
 - e. Check if the wire harness on the pickup unit and the feed sensor are connected correctly.

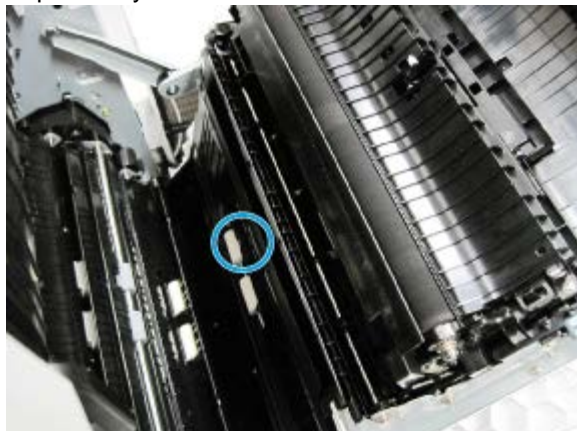
- b. Run test 102–0300, Tray 3 Feed Sensor.
- c. Trip the tray 3 feed sensor as shown in the following image to ensure that it is functioning correctly.

- d. If the sensor test fails, check if the wire harness on the guide-feed assembly is connected correctly.
- e. Check if the wire harness on the pickup unit and the feed sensor are connected correctly.

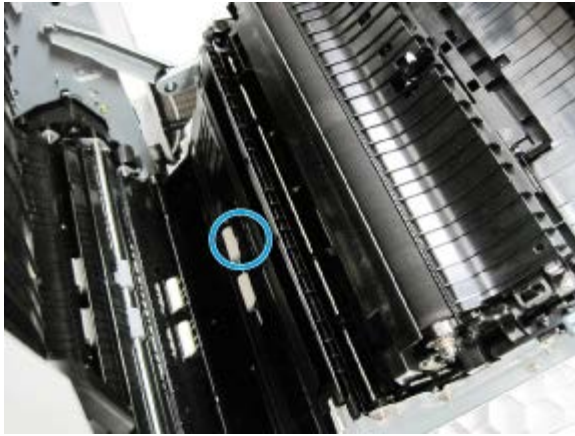
- b. Run test 102–0300, Tray 3 Feed Sensor.
- c. Trip the tray 3 feed sensor as shown in the following image to ensure that it is functioning correctly.

- d. If the sensor test fails, check if the wire harness on the guide-feed assembly is connected correctly.
 - e. Check if the wire harness on the pickup unit and the feed sensor are connected correctly.

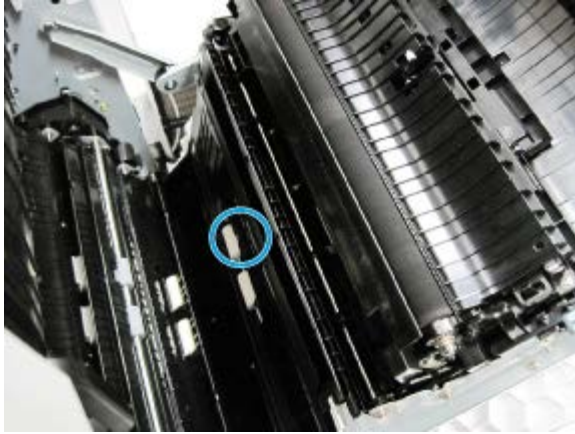
- Run test 102-0300, Tray 3 Feed Sensor.
- Trip the tray 3 feed sensor as shown in the following image to ensure that it is functioning correctly.

- If the sensor test fails, check if the wire harness on the guide-feed assembly is connected correctly.
 - Check if the wire harness on the pickup unit and the feed sensor are connected correctly.

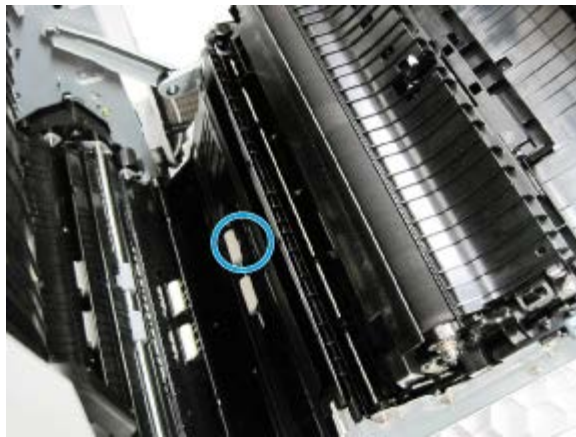
- Service Tools
 - Diagnostics
 - Engine Diagnostics
 - Engine Test Routines
 - b. Run test 102-0300, Tray 3 Feed Sensor.
 - c. Trip the tray 3 feed sensor as shown in the following image to ensure that it is functioning correctly.

- d. If the sensor test fails, check if the wire harness on the guide-feed assembly is connected correctly.
 - e. Check if the wire harness on the pickup unit and the feed sensor are connected correctly.

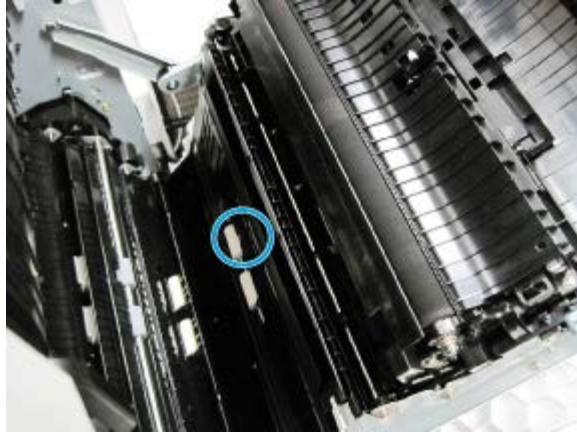
- b. Run test 102-0300, Tray 3 Feed Sensor.
- c. Trip the tray 3 feed sensor as shown in the following image to ensure that it is functioning correctly.

- d. If the sensor test fails, check if the wire harness on the guide-feed assembly is connected correctly.
 - e. Check if the wire harness on the pickup unit and the feed sensor are connected correctly.

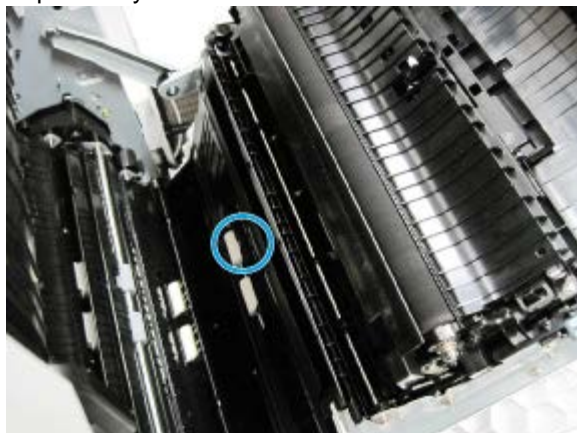
- Service Tools
 - Diagnostics
 - Engine Diagnostics
 - Engine Test Routines
- b. Run test 102-0300, Tray 3 Feed Sensor.
 - c. Trip the tray 3 feed sensor as shown in the following image to ensure that it is functioning correctly.

- d. If the sensor test fails, check if the wire harness on the guide-feed assembly is connected correctly.

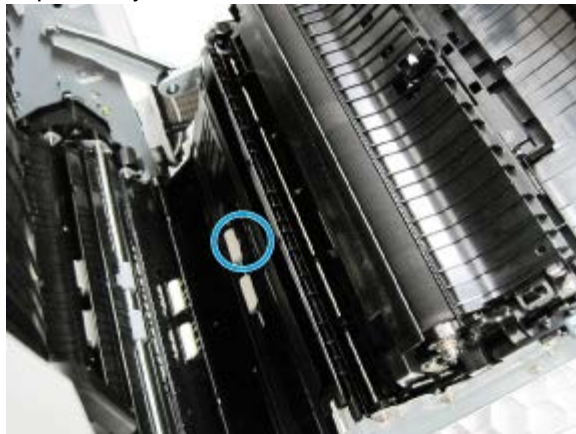
- b. Run test 102–0300, Tray 3 Feed Sensor.
- c. Trip the tray 3 feed sensor as shown in the following image to ensure that it is functioning correctly.

- d. If the sensor test fails, check if the wire harness on the guide-feed assembly is connected correctly.
- e. Check if the wire harness on the pickup unit and the feed sensor are connected correctly.
- f. If the wires are good, replace the tray 3 feed sensor.
Part number: SAM-0604-001490
- g. If the tray 3 feed sensor has been replaced and the sensor still does not function correctly, replace the main board PCA.
Part number: SAM-JC92-02958A
5. If tray 3 passes, check the paper path between the 3,000 input and the tray 3 pickup feed jam sensor. Look for any obstructions or damage to the paper path and replace parts as needed using the service manual.
6. Check the tray 6 (3,000 sheet feeder) pick up motor.
 - a. Open the following menus:

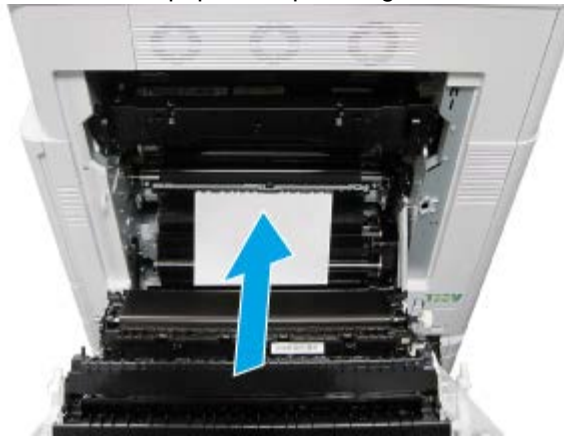
- b. Run test 102–0360, Registration Sensor
- c. Use a sheet of paper to trip the registration sensor to ensure that it is functioning correctly.

- d. If the sensor test fails, check the wire harness between the registration sensor and the main board PCA.
 - e. If the wire harness is good, replace the registration sensor or registration assembly.
Registration sensor part number: SAM-0604-001381
Registration assembly part number: SAM-JC93-01116A

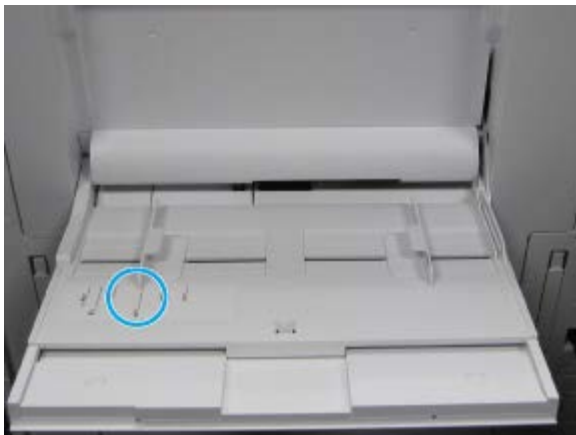
1. Remove any jammed paper from tray 1.
2. Ensure that the tray width guides are set to the correct paper size being installed into the tray. The arrow on the guide should line up exactly with the line connected to the paper size designation. Ensure that the tray is not filled above the fill mark on the tray.

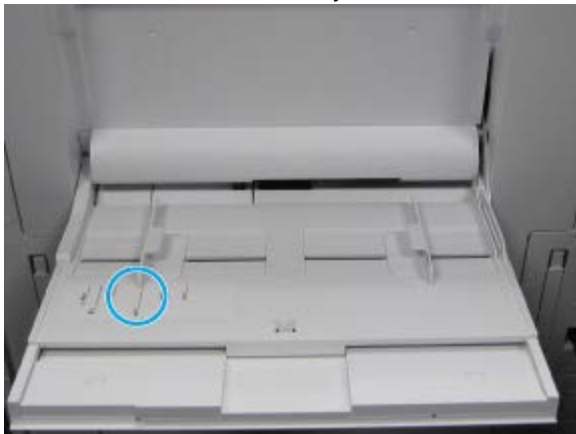
1. Remove any jammed paper from tray 1.
2. Ensure that the tray width guides are set to the correct paper size being installed into the tray. The arrow on the guide should line up exactly with the line connected to the paper size designation. Ensure that the tray is not filled above the fill mark on the tray.

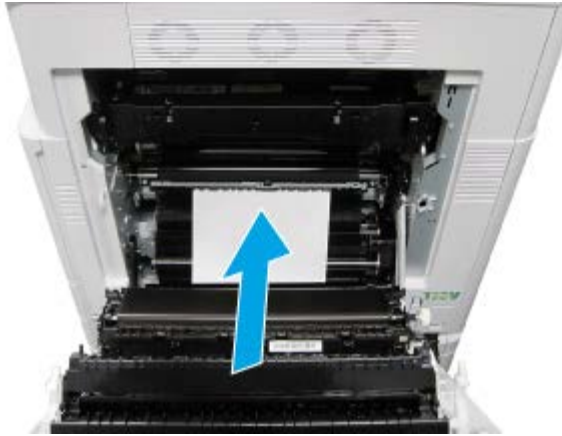
- b. Run test 102–0360, Registration Sensor.
- c. Use a sheet of paper to trip the registration sensor to ensure that it is functioning correctly.

- d. If the sensor test fails, check the wire harness between the registration sensor and the main board PCA.
 - e. If the wire harness is good, replace the registration sensor or registration assembly.
Registration sensor part number: SAM-0604-001381
Registration assembly part number: SAM-JC93-01116A

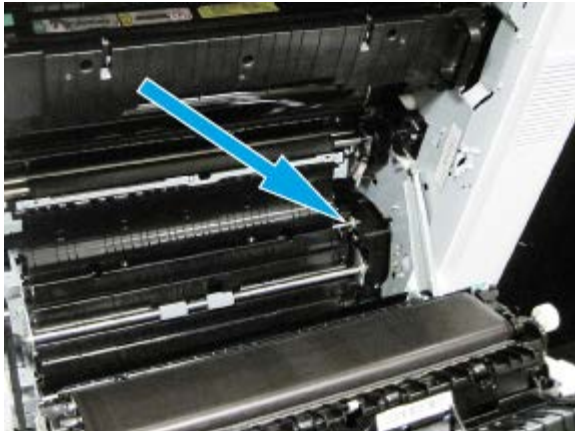
7. Check the tray 1 drive unit.
- a. Open the right door and run test 100–0420, Tray 1 Feed Motor.
 - b. Verify the motor is running by viewing the shaft in the following image.

- d. If the motor or the clutch does not function, check if both wiring harnesses are connected correctly.
- e. If the connection is good, replace the feed drive motor, feed drive clutch or the feed drive unit for tray 1 as needed.

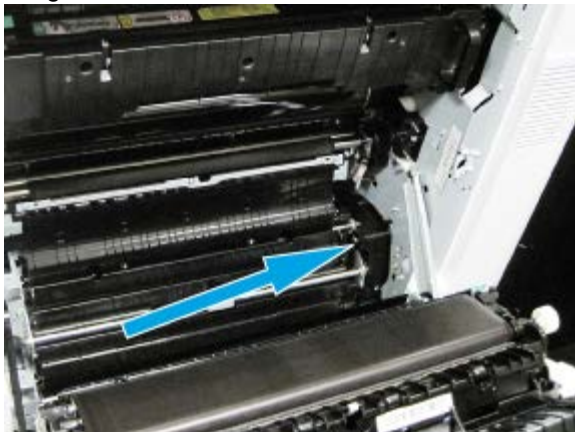
- c. Run test 101-0270, MP Clutch and verify the clutch is good by viewing the gear rotate in the following image.

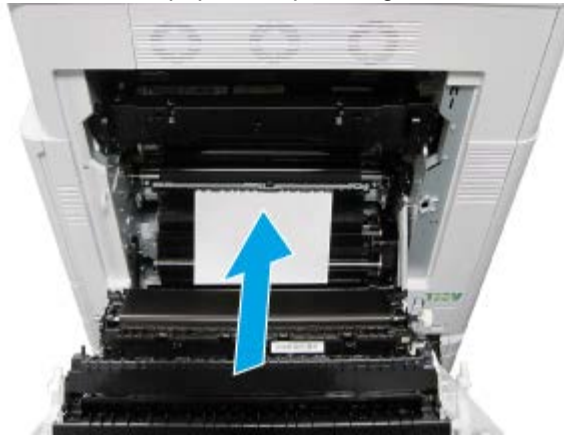
c. Use a sheet of paper to trip the registration sensor to ensure that it is functioning correctly.

- d. If the sensor test fails, check the wire harness between the registration sensor and the main board PCA.
- e. If the wire harness is good, replace the registration sensor or registration assembly.

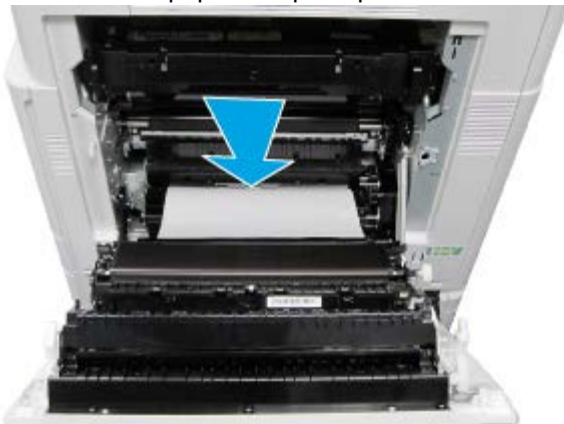
b. Use a sheet of paper to trip the pre-feed sensor to ensure that it is functioning correctly.

c. If the pre-feed sensor does not function correctly, replace the sensor.

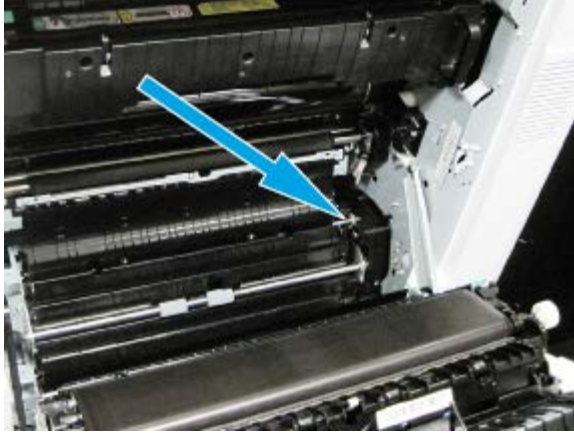
8. Check the tray 2 pickup drive unit.
 - a. Remove tray 2.
 - b. Run test 100-0370, Tray 2 Pick-Up Motor. Look inside the tray 2 opening and ensure that the pickup roller is rotating freely.
 - c. If the tray 2 motor does not function correctly, check the wire harness connection of tray 2 pickup drive unit.
 - d. If the tray 2 wire harness has no defects, replace the tray 2 pickup motor or pickup drive unit.
Pickup motor part number: SAM-JC93-01083A
Pickup drive part number: SAM-JC93-01063A
9. Check the tray 1 drive unit.
 - a. Open the right door and run test 100-0420, Tray 1 Motor.
 - b. Verify the motor is running by viewing the shaft in the following image.

- c. If the motor does not function, check if wiring harness is connected correctly.
- d. If the connection is good, replace the feed drive motor or the feed drive unit.
Feed drive motor part number: SAM-JC31-00132A
Feed drive unit part number: SAM-JC93-01062A

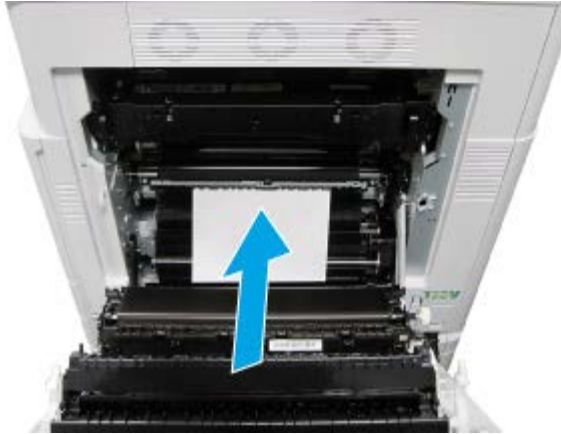
- c. Run test 102–0360, Registration Sensor.
- d. Use a sheet of paper to trip the registration sensor to ensure that it is functioning correctly.

- e. If the sensor test fails, check the wire harness between the registration sensor and the main board PCA.
 - f. If the wire harness is good, replace the registration sensor or registration assembly.
Registration sensor part number: SAM-0604-001381
Registration assembly part number: SAM-JC93-01116A
5. Open tray 3. Remove any jammed paper from the tray.
 6. Ensure that the tray width guides are set to the correct paper size being installed into the tray. The arrow on the guide should line up exactly with the line connected to the paper size designation. Ensure that the tray is not filled above the fill mark on the tray.

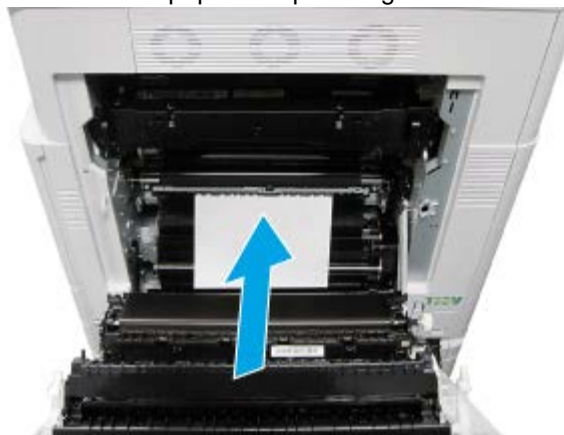
- Service Tools
 - Diagnostics
 - Engine Diagnostics
 - Engine Test Routines
 - c. Run test 102–0360, Registration Sensor.
 - d. Use a sheet of paper to trip the registration sensor to ensure that it is functioning correctly.

- e. If the sensor test fails, check the wire harness between the registration sensor and the main board PCA.
- f. If the wire harness is good, replace the registration sensor or registration assembly.
Registration sensor part number: SAM-0604-001381
Registration assembly part number: SAM-JC93-01116A

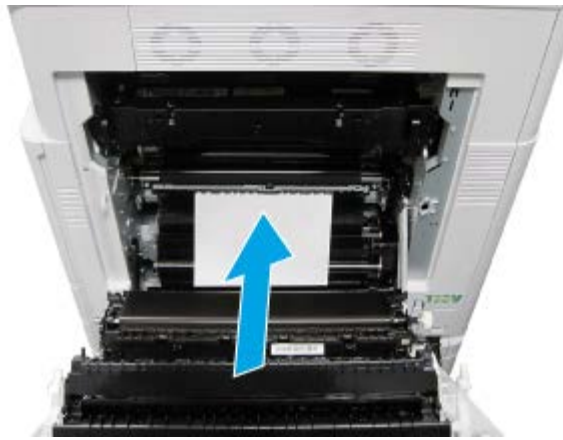
- Service Tools
 - Diagnostics
 - Engine Diagnostics
 - Engine Test Routines
 - c. Run test 102-0360, Registration Sensor.
 - d. Use a sheet of paper to trip the registration sensor to ensure that it is functioning correctly.

- e. If the sensor test fails, check the wire harness between the registration sensor and the main board PCA.
 - f. If the wire harness is good, replace the registration sensor or registration assembly.
Registration sensor part number: SAM-0604-001381
Registration assembly part number: SAM-JC93-01116A
6. Ensure that the tray is not filled above the fill mark on the tray.
 7. Check the tray 6 pick-up and feed rollers for wear, damage, or paper dust. Clean the rollers with a damp, lint free cloth.
 8. If the pick-up/reverse/forward rollers are worn out or contaminated, replace the defective roller.
Part number: X3A92-67917
 9. Check the tray 6 (3,000 sheet feeder) pick up motor.
 - a. Open the following menus:
 - Support Tools
 - Service

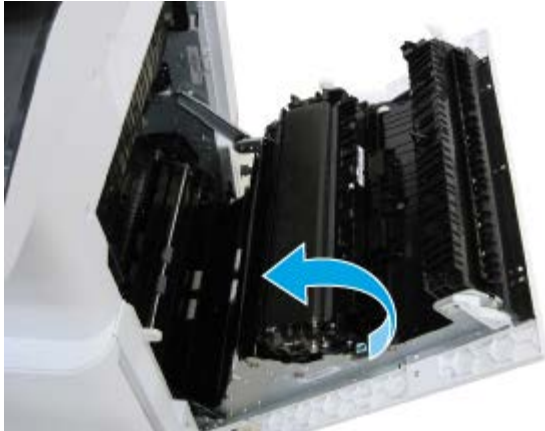
3: Open the duplex path

1. Open the right door. Remove any jammed paper found.
2. Open the duplex path and remove any paper found.

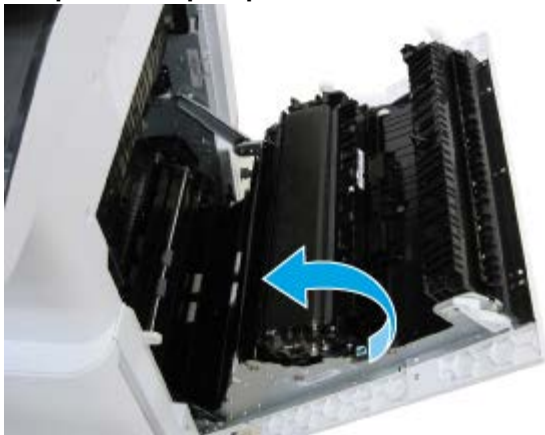
5: Open the duplex path

1. Open the right door. Remove any jammed paper found.
2. Open the duplex path and remove any paper found.

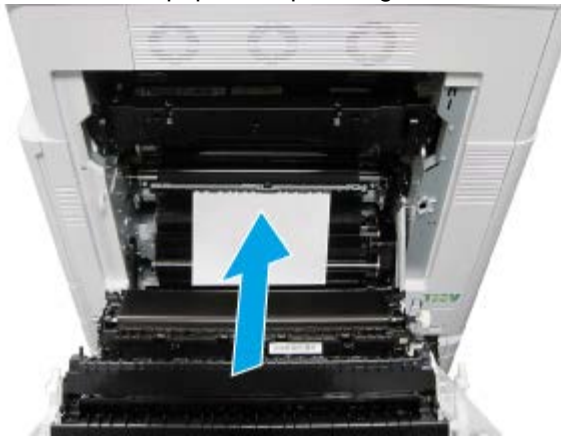
- c. Run test 102-0360, Registration Sensor.
- d. Use a sheet of paper to trip the registration sensor to ensure that it is functioning correctly.

- e. If the sensor test fails, check the wire harness between the registration sensor and the main board PCA.
 - f. If the wire harness is good, replace the registration sensor or registration assembly.
Registration sensor part number: SAM-0604-001381
Registration assembly part number: SAM-JC93-01116A
5. If error persists, check the paper feed motor.
 - a. Run test 100-0340, Feed Motor and listen for the motor to operate.
 - b. If the test fails, check if the wire harness on the feed drive assembly is connected correctly.
 - c. If the error persists, replace the feed motor or the feed drive assembly.
Feed motor part number: SAM-JC31-00132A
Feed drive assembly part number: SAM-JC93-01062A
 6. Test the duplex motor.
 - a. Open the following menus:
 - Support Tools

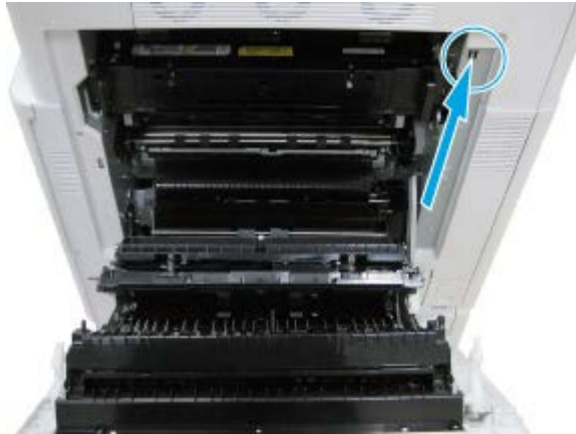
- b. Run test 100–0490, Duplex 2 Motor forward.
-

To run this test, the right door sensor might need to be tripped.

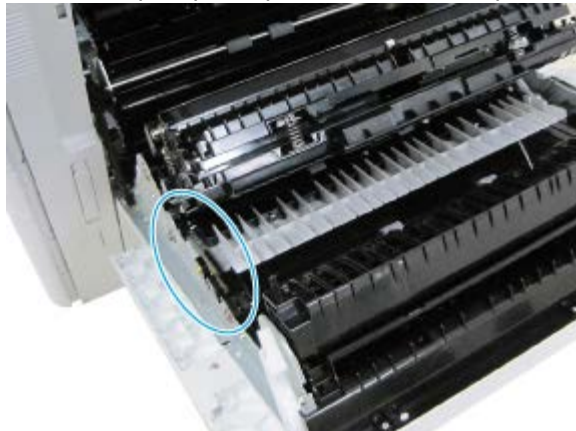
- c. With the duplex path open, observe the duplex drive belt to ensure the motor is functioning correctly.

- d. If the sensor test fails, check the wire harness between the duplex drive.
 e. If the wire harness is good, replace the duplex motor.

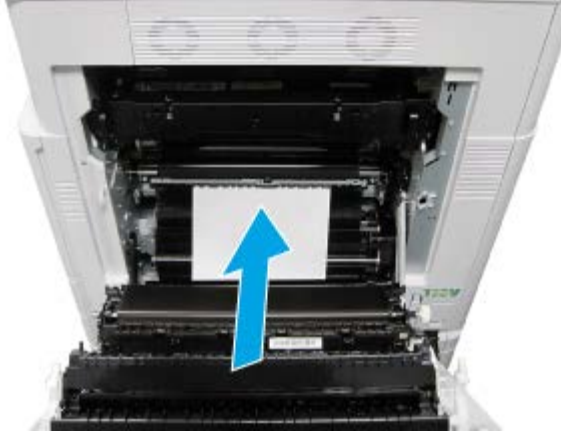
- Service Tools
 - Diagnostics
 - Engine Diagnostics
 - Engine Test Routines
 - c. Run test 102–0360, Registration Sensor.
 - d. Use a sheet of paper to trip the registration sensor to ensure that it is functioning correctly.

- e. If the sensor test fails, check the wire harness between the registration sensor and the main board PCA.
- f. If the wire harness is good, replace the registration sensor or registration assembly.
 Registration sensor part number: SAM-0604-001381
 Registration assembly part number: SAM-JC93-01116A

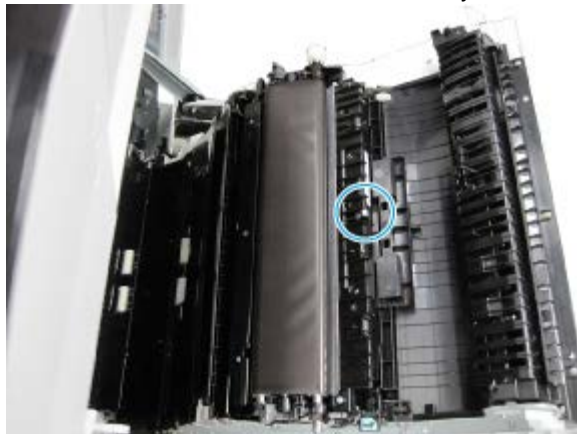
1. Open the right door. Remove any jammed paper found.
2. Check if there is any obstruction or paper jammed inside the printer. If there is, remove it.
3. Check the loop detection sensor.
 - a. Ensure the sensor actuator moves freely and is not damaged.

- b. If the actuator is damaged or the sensor does not function correctly, replace the cartridge sub-cover rear.
Part number: SAM-JC96-09859A
4. Test the registration assembly.

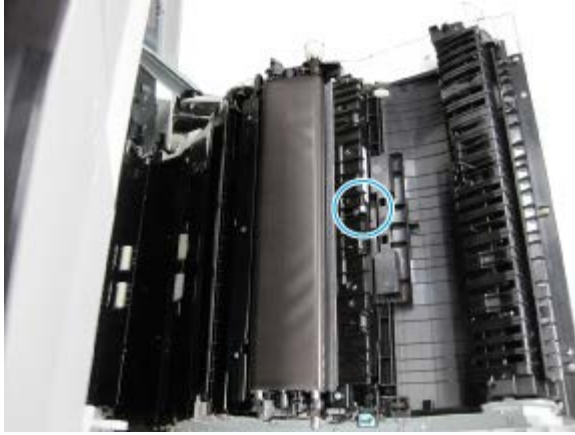
- a. Ensure the sensor actuator moves freely and is not damaged.

- b. If the actuator is damaged or the sensor does not function correctly, replace the cartridge sub-cover rear.
Part number: SAM-JC96-09859A

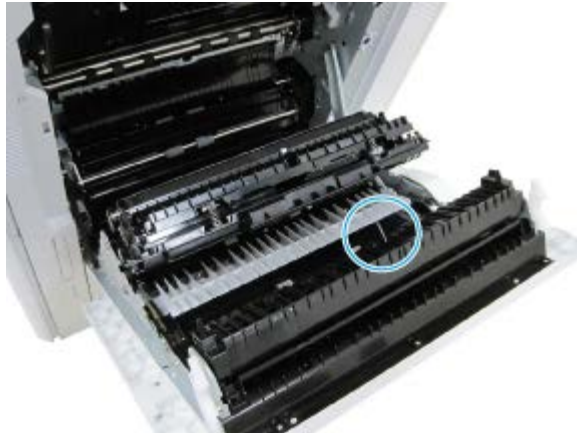
- b. Run test 102-0361, the Fuser Out Sensor test.

- c. If the sensor operation is normal, skip to the step for checking the fuser and exit drive unit.
 - d. If the sensor does not work, check the wire harness connection between fuser exit sensor and main board.

- e. If the wire harness connection is OK, replace the fuser exit sensor or arm if damaged.
Actuator fuser out part number: SAM-JC66-04406A
Sensor part number: SAM-0604-001393

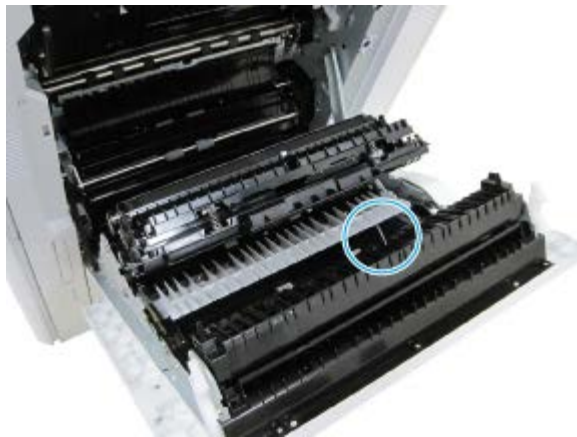
- b. Run test 102-0361, the Fuser Out Sensor test.

- c. If the sensor operation is normal, skip to the step for checking the registration unit.
 - d. If the sensor does not work, check the wire harness connection between the fuser exit sensor and main board.

- e. If the wire harness connection is OK, replace the fuser exit sensor or arm if damaged.
Actuator fuser out part number: SAM-JC66-04406A
Sensor part number: SAM-0604-001393

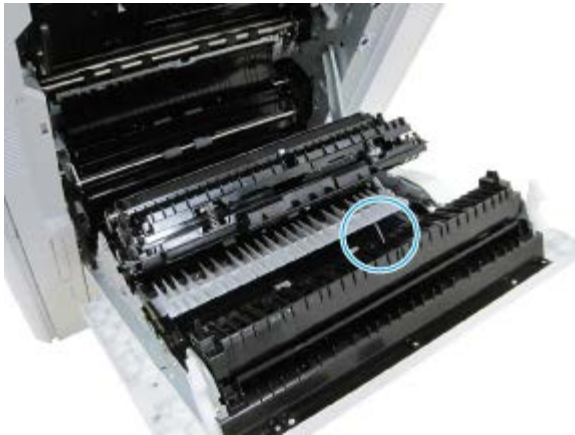
- b. Run test 102-0361, the Fuser Out Sensor test.

- c. If the sensor does not work, check the wire harness connection between the fuser exit sensor and the main board.
- d. If the wire harness connection is OK, replace the fuser exit sensor or arm if damaged.
Actuator fuser out part number: SAM-JC66-04406A
Sensor part number: SAM-0604-001393

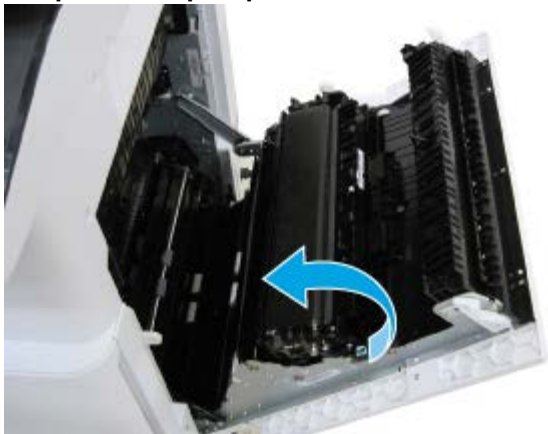
9: Open the duplex path

1. Open the right door. Remove any jammed paper found.
2. Open the duplex path and remove any paper found.

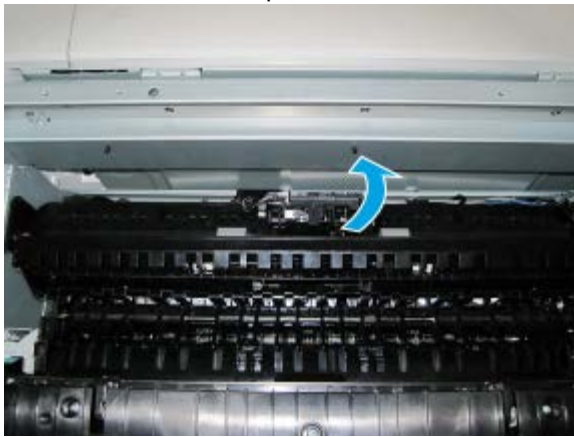
- c. Run test 102-0380, Duplex Jam 1 Sensor.

- d. If the sensor operation is normal, skip to the step for checking the exit 2 drive unit.
 - e. If the sensor does not work, check the wire harness connection between the output upper 2 unit and the main board.
 - f. If the wire harness connection is OK, replace the output upper 2 unit.
Part number: SAM-JC90-01374A
5. If the sensor works normally, check the exit 2 drive unit.
 - a. Run test 100-0430, Exit 2 Motor Forward.
 - b. If the motor test is normal, skip to the step for checking the duplex 2 drive.
 - c. If the test fails, check the wire harness connection of Exit 2 drive unit.
 - d. If the wire harness connection is OK, replace the output upper 2 unit.
Part number: SAM-JC90-01374A
 6. Check the duplex 2 drive.
 - a. Run test 100-0490, Duplex 2 Motor forward.

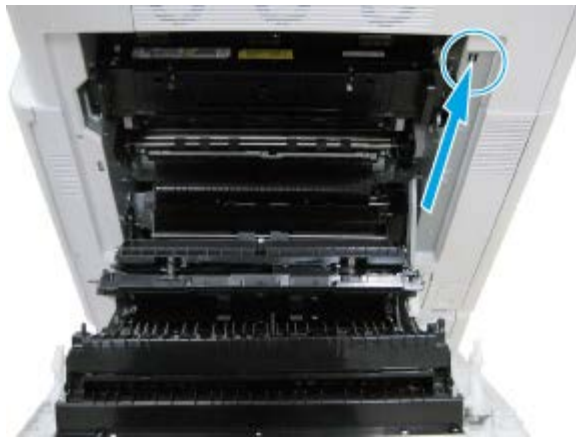
To run this test, the right door sensor might need to be tripped.

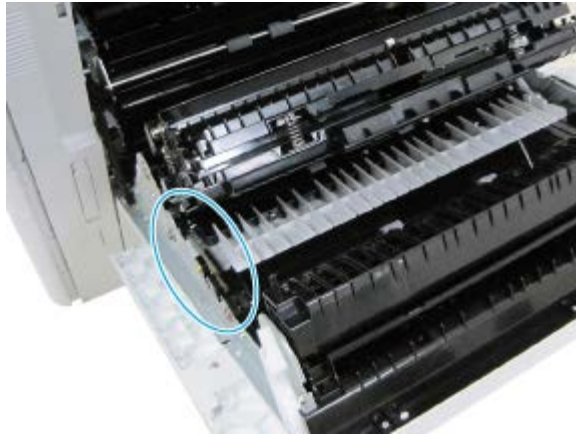
- b. With the duplex path open, observe the duplex drive belt to ensure the motor is functioning correctly.

- c. If the sensor test fails, check the wire harness between the duplex drive.
 d. If the wire harness is good, replace the duplex motor.
 Part number: SAM-JC93-01085A
7. Inspect the duplex path for obstructions or damage. If parts are damaged replace them as needed.
 Side cover guide part number: SAM-JC95-01969A
 Side cover output part number: SAM-JC95-01968A
 Side cover takeaway part number: SAM-JC95-01972A

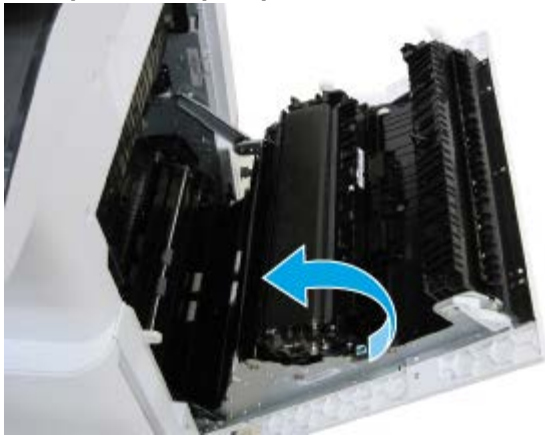
11: Open the duplex path

- Open the right door. Remove any jammed paper found.
- Open the duplex path and remove any paper found.

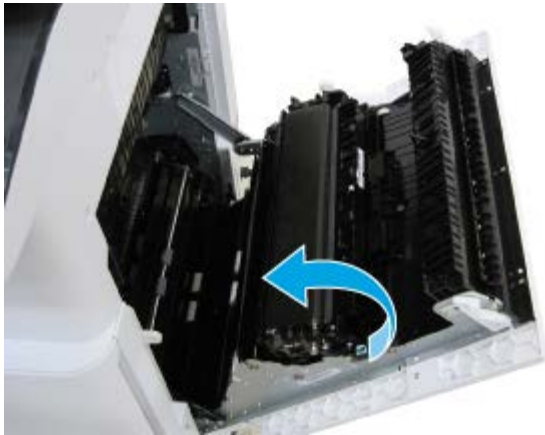
17: Open the duplex path

1. Open the right door. Remove any jammed paper found.
2. Open the duplex path and remove any paper found.

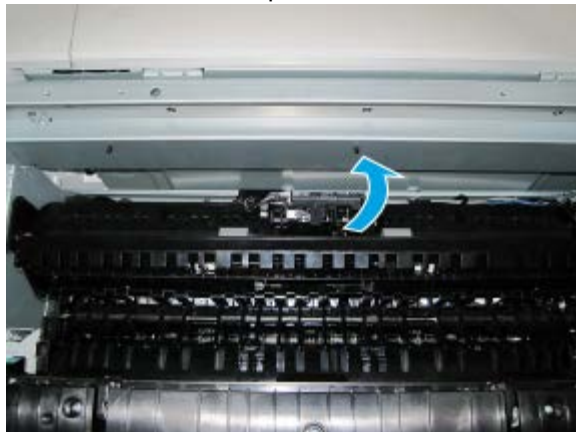
- Service Tools
 - Diagnostics
 - Engine Diagnostics
 - Engine Test Routines
 - c. Run test 102-0380, Duplex Jam 1 Sensor.

- d. If the sensor does not work, check the wire harness connection between the output upper 2 unit and the main board.
- e. If the wire harness connection is OK, replace the output upper 2 unit.
Part number: SAM-JC90-01374A

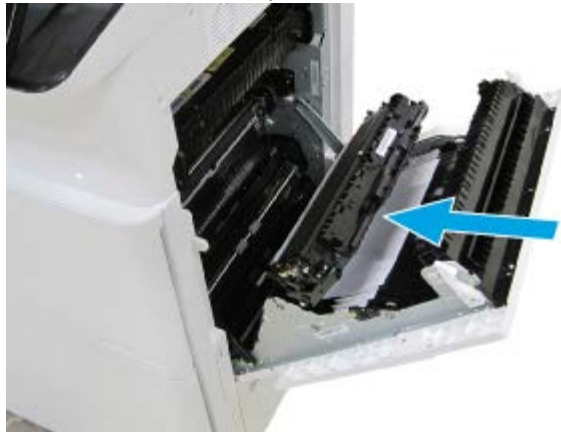
- c. Run test 102-0390, Duplex Jam 2 Sensor.

- d. If the sensor operation is normal, skip to the step for checking the duplex 2 drive.

- e. If the sensor does not work, check the wire harness connection between the right door and the sensor and the main board.
 - f. If the sensor actuator is damaged, replace it.
Part number: SAM-JC66-04405A
 - g. If the wire harness connection is OK and the sensor test failed, replace the sensor.
Part number: SAM-0604-001393
5. Check the duplex 2 drive.
 - a. Run test 100–0490, Duplex 2 Motor forward.

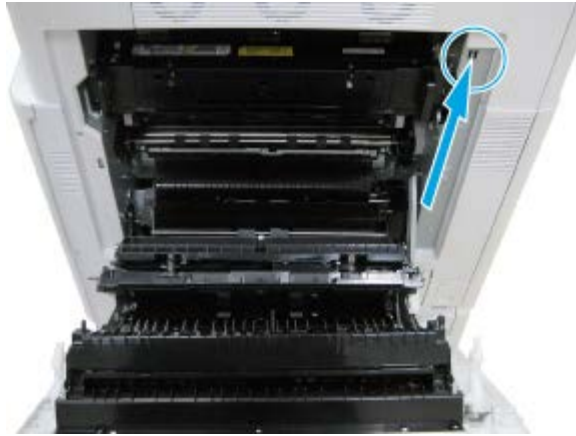
To run this test, the right door sensor might need to be tripped.

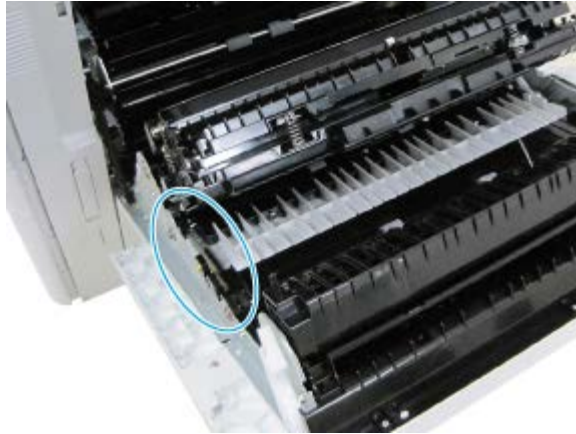
- b. With the duplex path open, observe the duplex drive belt to ensure the motor is functioning correctly.

- c. If the sensor test fails, check the wire harness between the duplex drive.
 - d. If the wire harness is good, replace the duplex motor.
Part number: SAM-JC93-01085A
6. Inspect the duplex path for obstructions or damage. If parts are damaged replace them as needed.
Side cover guide part number: SAM-JC95-01969A
Side cover output part number: SAM-JC95-01968A
Side cover takeaway part number: SAM-JC95-01972A
 7. If error persists, check the paper feed motor.
 - a. Run test 100-0340, Feed Motor and listen for the motor to operate.
 - b. If the test fails, check if the wire harness on the feed drive assembly is connected correctly.
 - c. If the error persists, replace the feed motor or the feed drive assembly.
Feed motor part number: SAM-JC31-00132A
Feed drive assembly part number: SAM-JC93-01062A

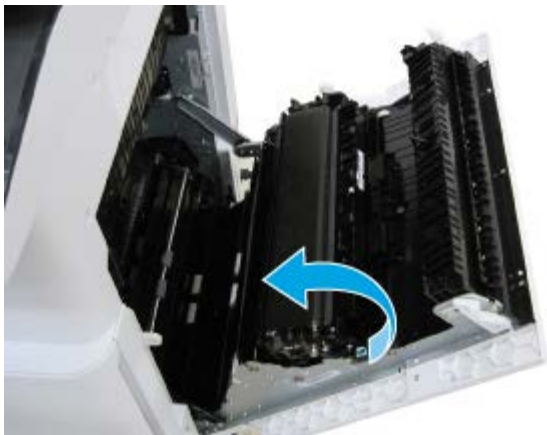
25: Open the duplex path

1. Open the right door. Remove any jammed paper found.
2. Open the duplex path and remove any paper found.

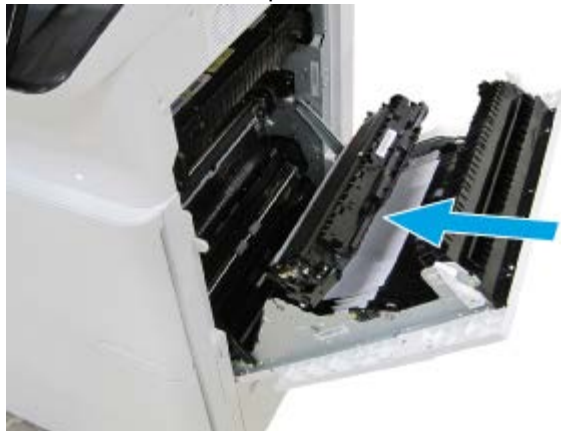
- Service Tools
 - Diagnostics
 - Engine Diagnostics
 - Engine Test Routines
- c. Run test 102-0390, Duplex Jam 2 Sensor.

- d. If the sensor operation is normal, skip to the step for checking the duplex 2 drive.
- e. If the sensor does not work, check the wire harness connection between the right door and the sensor and the main board.

- f. If the sensor actuator is damaged, replace it.
Part number: SAM-JC66-04405A
 - g. If the wire harness connection is OK and the sensor test failed, replace the sensor.
Part number: SAM-0604-001393
5. Check the duplex 2 drive.
 - a. Run test 100–0490, Duplex 2 Motor forward.

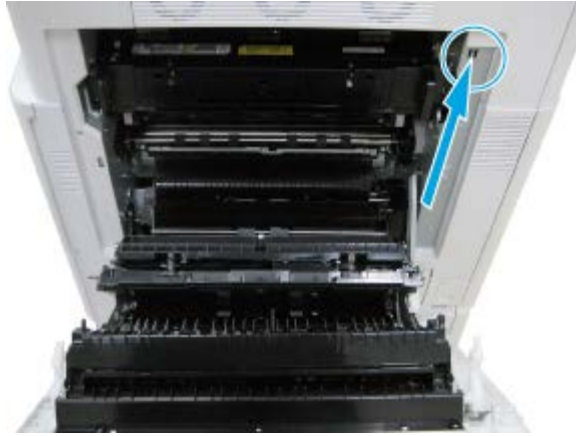
To run this test, the right door sensor might need to be tripped.

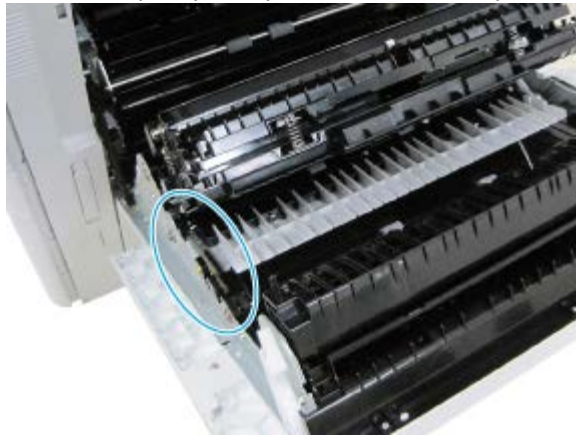
- b. With the duplex path open, observe the duplex drive belt to ensure the motor is functioning correctly.

- c. If the sensor test fails, check the wire harness between the duplex drive.
 - d. If the wire harness is good, replace the duplex motor.
Part number: SAM-JC93-01085A
6. Inspect the duplex path for obstructions or damage. If parts are damaged replace them as needed.
Side cover guide part number: SAM-JC95-01969A
Side cover output part number: SAM-JC95-01968A
Side cover takeaway part number: SAM-JC95-01972A

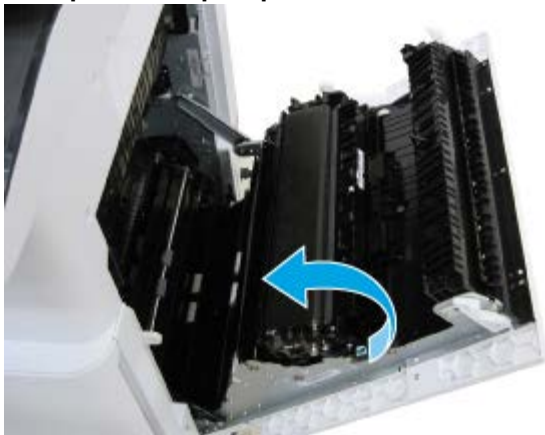
29: Open the duplex path

1. Open the right door. Remove any jammed paper found.
2. Open the duplex path and remove any paper found.

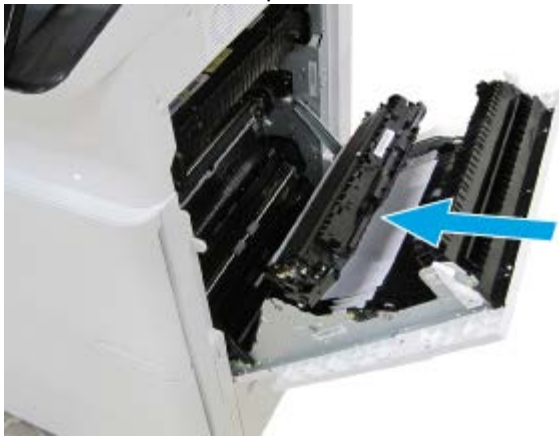
- c. Run test 102-0390, Duplex Jam 2 Sensor.

- d. If the sensor does not work, check the wire harness connection between the right door and the sensor and the main board.
- e. If the sensor actuator is damaged, replace it.
Part number: SAM-JC66-04405A
- f. If the wire harness connection is OK and the sensor test failed, replace the sensor.
Part number: SAM-0604-001393

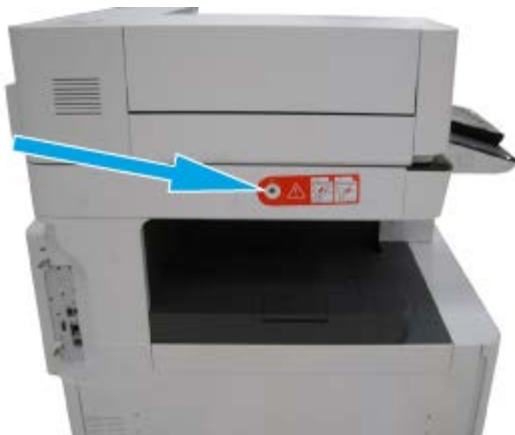
1. Turn the printer off.
2. Make sure the scanner lock screw is removed.

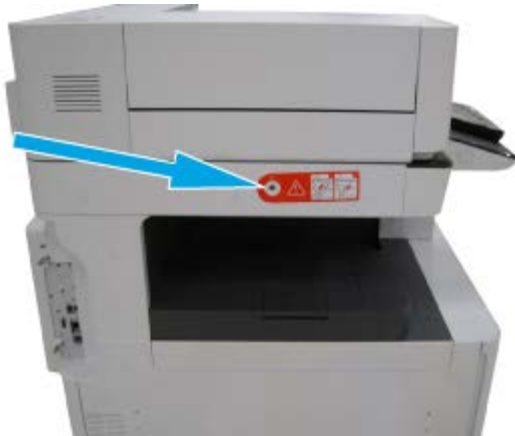
1. Turn the printer off.
2. Make sure the scanner lock screw is removed.

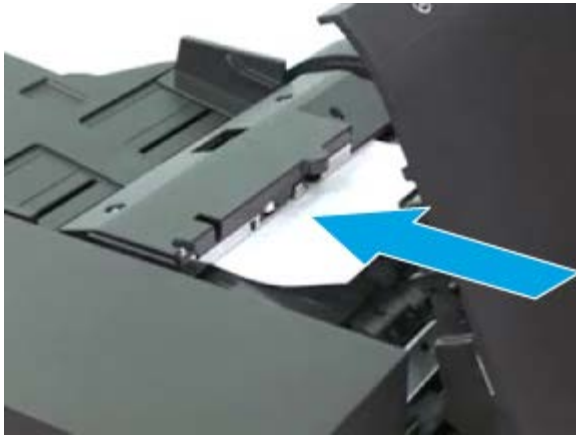
1. Open the document feeder and remove any jammed paper, then close the cover and check whether it operates again.
2. Test the document feed sensor.

- b. Run test 05–0060, Document Simplex Registration Sensor.
 c. If the sensor does not function correctly, replace the sensor.
 Part number: SAM-0604–001381

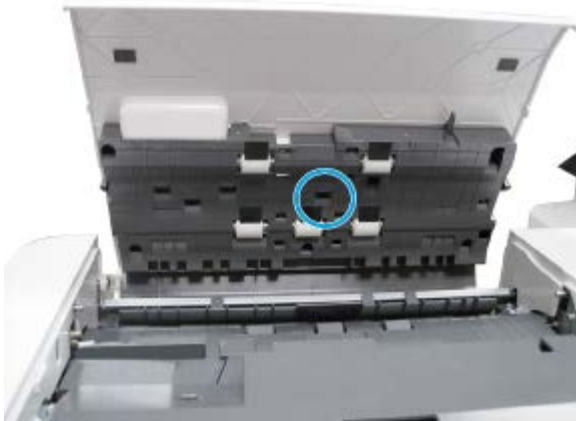
3. Test the simplex registration sensor.

- a. Run test 05–0060, Document Simplex Registration Sensor.
 b. If the sensor does not function correctly replace the document feeder open cover.
 Part number: SAM-JC97-04869A
