HP LaserJet Managed Flow MFP E82540-E82560 series and HP LaserJet Managed MFP E82540-E82560 series - Control panel message document (CPMD)

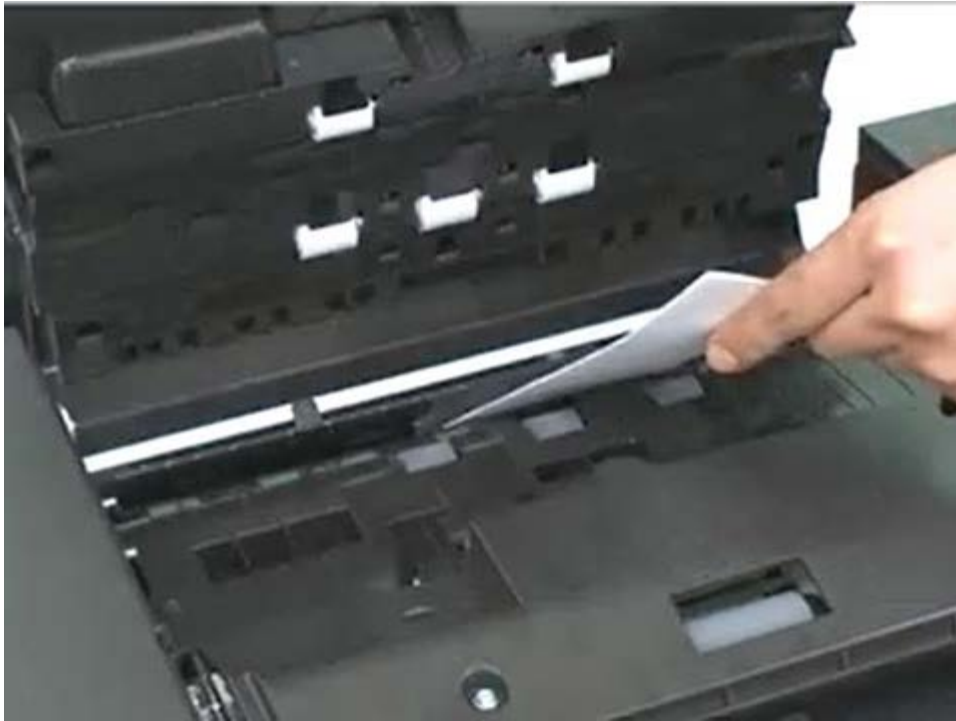
4. If this error occurs continually, check the duplex registration sensor.

- a. Run test 05–0061, Document Duplex Registration Sensor.
 - b. If the sensor is defective, replace the document feeder contact image sensor.
Part number: SAM-0609-001558
5. If this error occurs continually, check the document feeder scan in sensor.

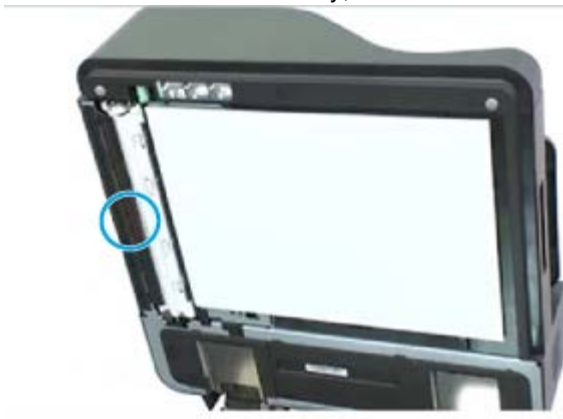
- a. Run test 05–0070, Document Scan Read Sensor 1.
 - b. If the sensor is defective, replace the scan-in-lower assembly.
Part number: SAM-JC97-04656B
6. If this error occurs continually, check the document feeder scan out sensor.

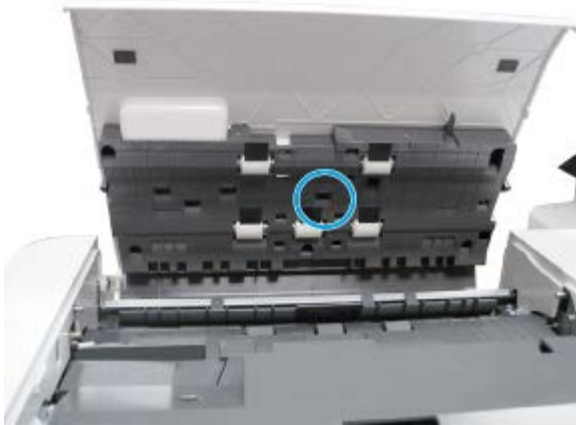
1. Open the document feeder and remove any jammed paper, then close the cover and check whether it operates again.
2. Test the simplex registration sensor.

c. If the sensor does not function correctly replace the document feeder open cover.
Part number: SAM-JC97-04869A

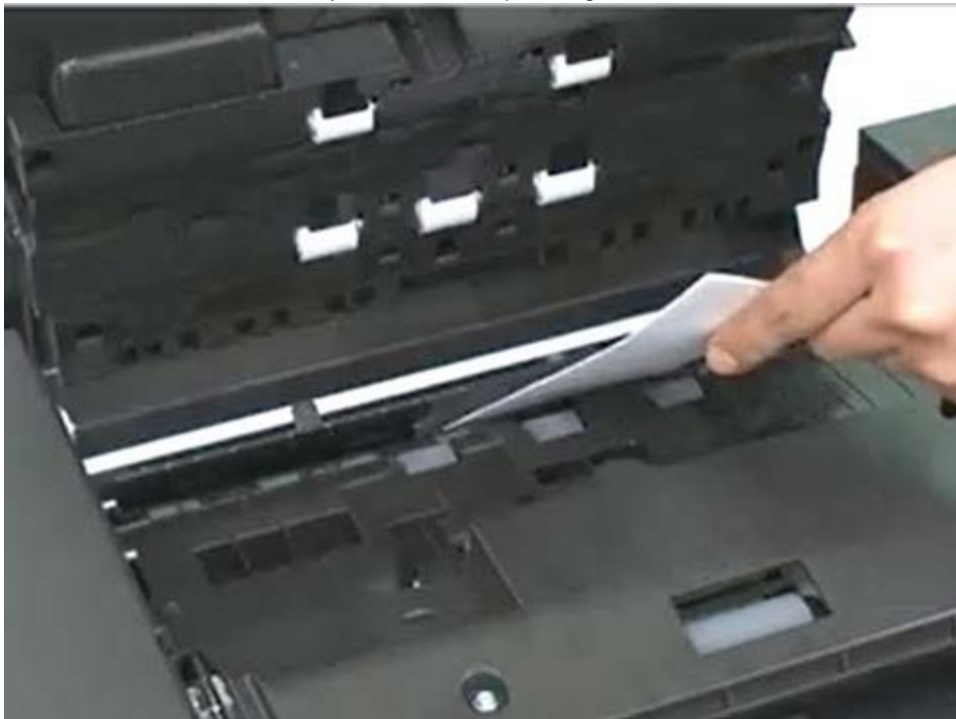
3. If this error occurs continually, check the duplex registration sensor.

a. Run test 05–0061, Document Duplex Registration Sensor.

b. If the sensor is defective, replace the document feeder contact image sensor.
Part number: SAM-0609-001558

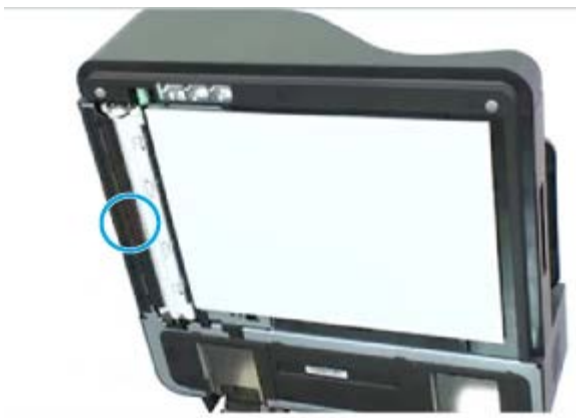
4. If this error occurs continually, check the document feeder scan in sensor.

- a. Run test 05–0070, Document Scan Read Sensor 1.
 - b. If the sensor is defective, replace the scan in lower assembly.
Part number: SAM-JC97-04656B
5. If this error occurs continually, check the document feeder scan out sensor.

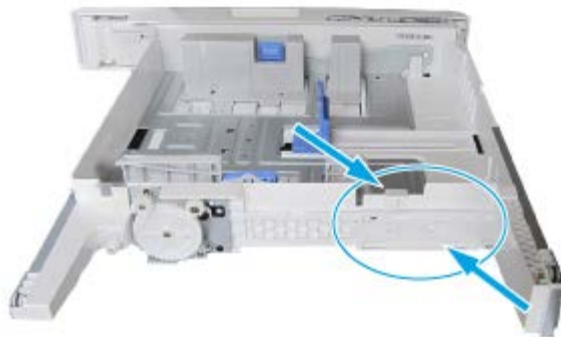
3. If the error persists, check the tray and the tray size sensors.
 - a. Check the failing tray to ensure that when the tray guides are moved the sensor guides on the back of the tray move and are not damaged. If they are damaged, replace the tray.
 Tray 2 part number: SAM-JC90-01610A
 Tray 3 part number: SAM-JC90-01611A
 Tray 4 part number: SAM-JC90-01652A
 Tray 5 part number: SAM-JC90-01654A

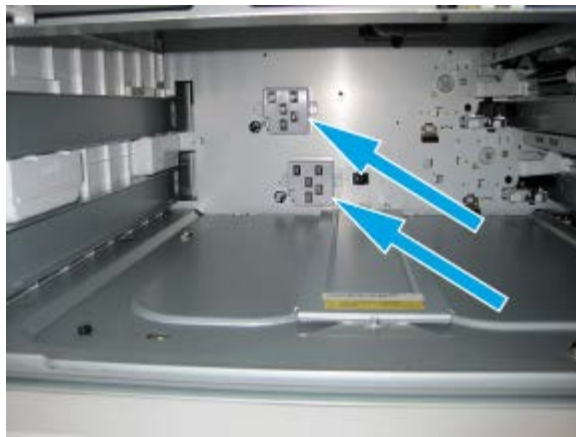
- b. Check if the failing tray sensor fingers are damaged or seated correctly. Reseat or replace the sensor assembly as needed.
 Part number: SAM-JC92-02622A

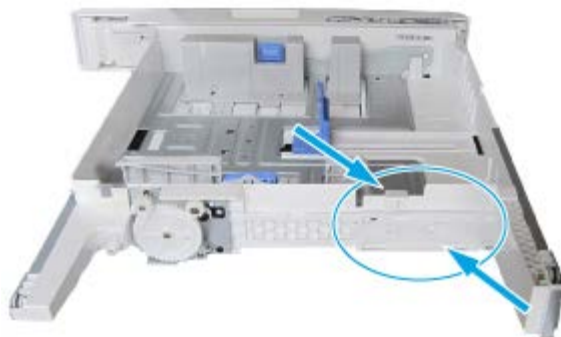
- a. Check the failing tray to ensure that when the tray guides are moved the sensor guides on the back of the tray move and are not damaged. If they are damaged, replace the tray.

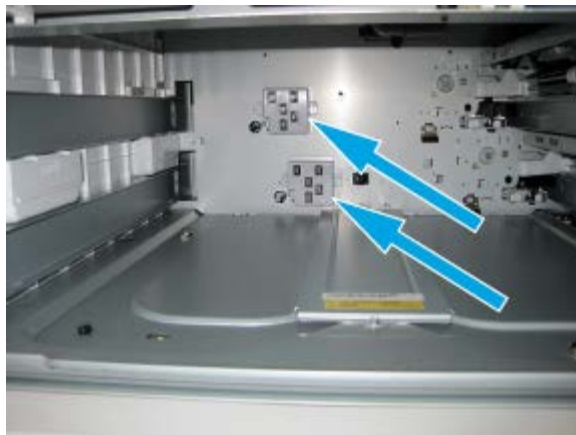
- b. Check if the failing tray sensor fingers are damaged or seated correctly. Reseat or replace the sensor assembly as needed.

Part number: SAM-JC92-02622A

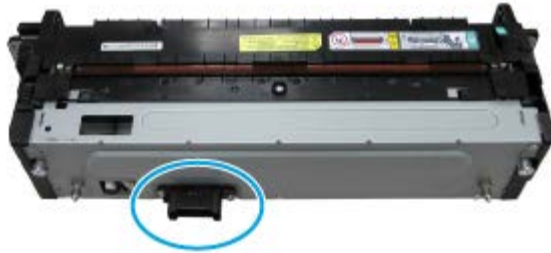
3. Ensure that the printer is not located in front of a vent or window where the cool air might interfere with the ability of the fuser to heat up.
4. Check the connector on the fuser for damage or broken pins. If needed replace the fuser.
110V fuser part number: SAM-JC91-01195A
220V fuser part number: SAM-JC91-01194A

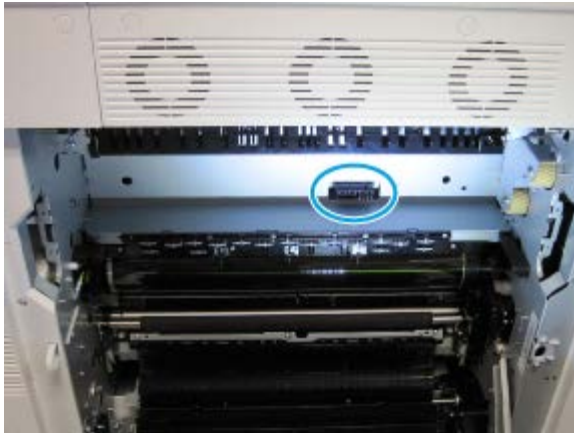
5. Check the connector inside the printer that connects to the fuser. If the connector is damaged, replace the fuser connector assembly.
Part number: TBD

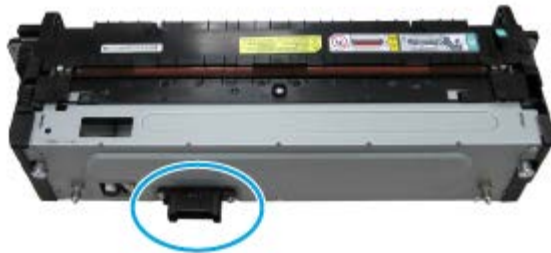
5. Ensure that the printer is not located in front of a vent or window where the cool air might interfere with the ability of the fuser to heat up.
6. Check the connector on the fuser for damage or broken pins. If needed replace the fuser.
110V fuser part number: SAM-JC91-01195A
220V fuser part number: SAM-JC91-01194A

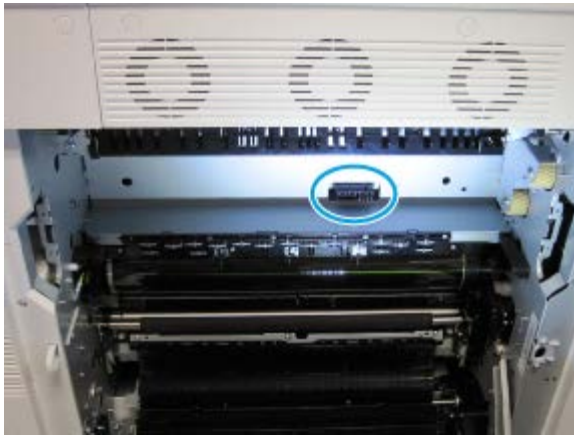
7. Check the connector inside the printer that connects to the fuser. If the connector is damaged, replace the fuser connector assembly.
Part number: TBD

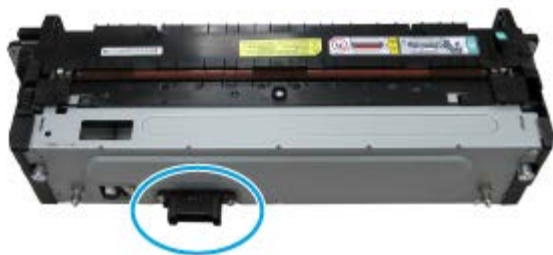
5. Ensure that the printer is not located in front of a vent or window where the cool air might interfere with the ability of the fuser to heat up.
6. Check the connector on the fuser for damage or broken pins. If needed replace the fuser.
 110V fuser part number: SAM-JC91-01195A
 220V fuser part number: SAM-JC91-01194A

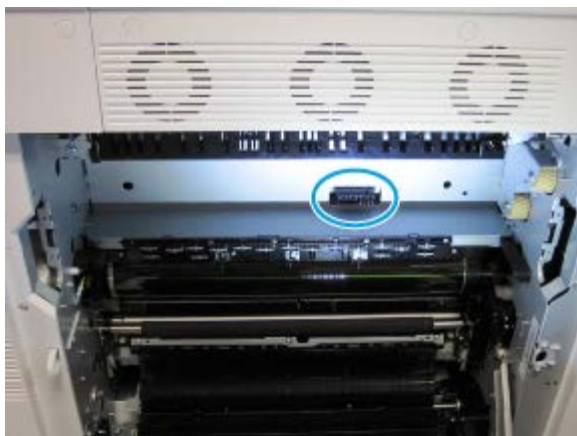
7. Check the connector inside the printer that connects to the fuser. If the connector is damaged, replace the fuser connector assembly.

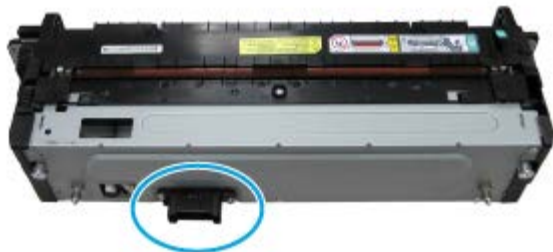
5. Ensure that the printer is not located in front of a vent or window where the cool air might interfere with the ability of the fuser to heat up.
6. Check the connector on the fuser for damage or broken pins. If needed replace the fuser.
110V fuser part number: SAM-JC91-01195A
220V fuser part number: SAM-JC91-01194A

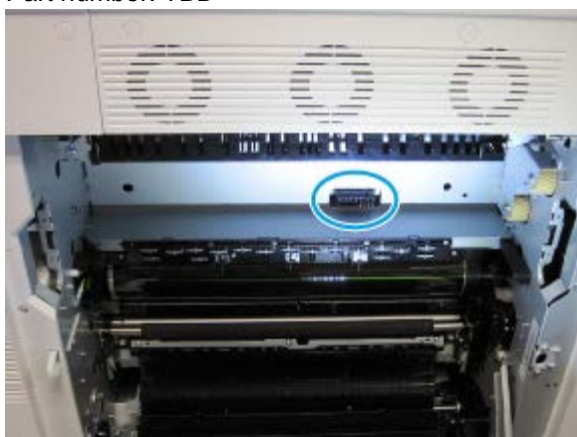
7. Check the connector inside the printer that connects to the fuser. If the connector is damaged, replace the fuser connector assembly.
Part number: TBD

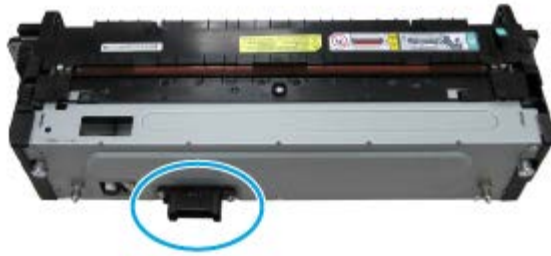
5. Check the connector on the fuser for damage or broken pins. If needed replace the fuser.
110V fuser part number: SAM-JC91-01195A
220V fuser part number: SAM-JC91-01194A

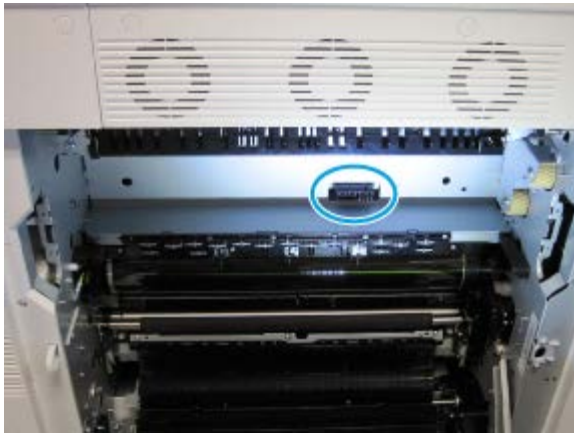
6. Check the connector inside the printer that connects to the fuser. If the connector is damaged, replace the fuser connector assembly.
Part number: TBD

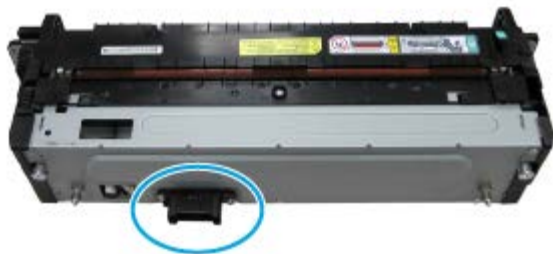
5. Check the connector on the fuser for damage or broken pins. If needed replace the fuser.
110V fuser part number: SAM-JC91-01195A
220V fuser part number: SAM-JC91-01194A

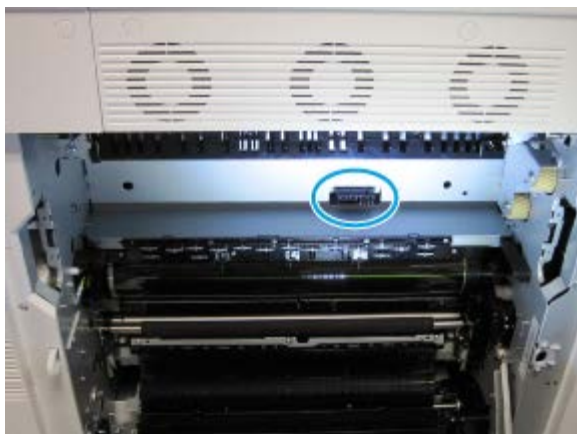
6. Check the connector inside the printer that connects to the fuser. If the connector is damaged, replace the fuser connector assembly.
Part number: TBD

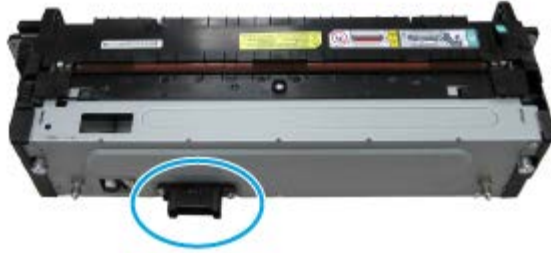
5. Check the connector on the fuser for damage or broken pins. If needed replace the fuser.
110V fuser part number: SAM-JC91-01195A
220V fuser part number: SAM-JC91-01194A

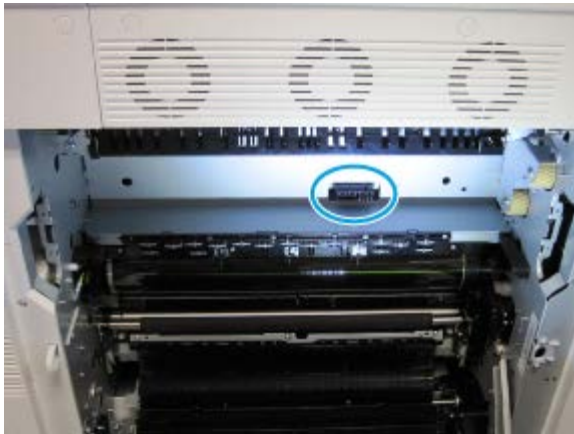
6. Check the connector inside the printer that connects to the fuser. If the connector is damaged, replace the fuser connector assembly.
Part number: TBD

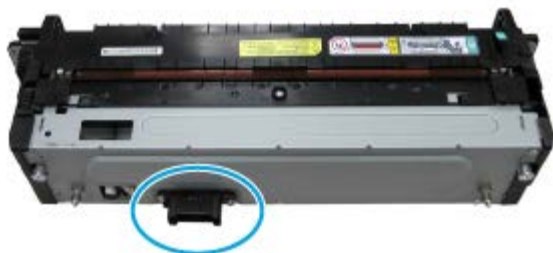
5. Check the connector on the fuser for damage or broken pins. If needed replace the fuser.
110V fuser part number: SAM-JC91-01195A
220V fuser part number: SAM-JC91-01194A

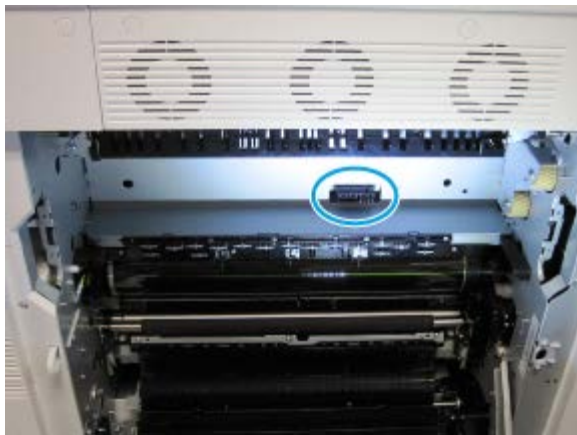
6. Check the connector inside the printer that connects to the fuser. If the connector is damaged, replace the fuser connector assembly.
Part number: TBD

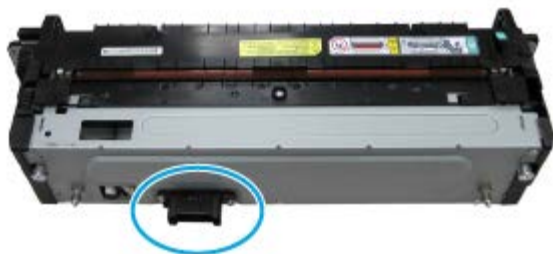
5. Ensure that the printer is not located in front of a vent or window where the cool air might interfere with the ability of the fuser to heat up.
6. Check the connector on the fuser for damage or broken pins. If needed replace the fuser.
110V fuser part number: SAM-JC91-01195A
220V fuser part number: SAM-JC91-01194A

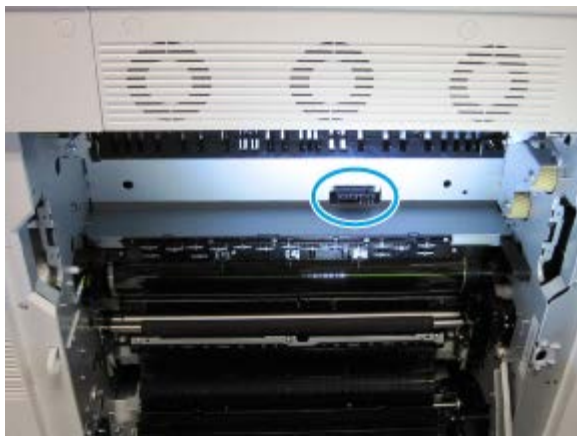
7. Check the connector inside the printer that connects to the fuser. If the connector is damaged, replace the fuser connector assembly.
Part number: TBD

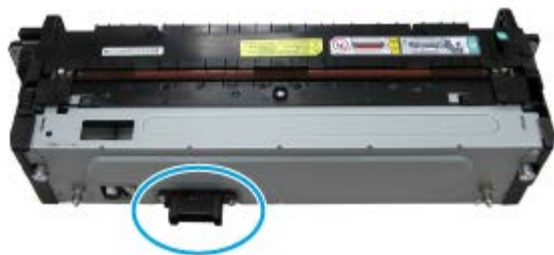
5. Ensure that the printer is not located in front of a vent or window where the cool air might interfere with the ability of the fuser to heat up.
6. Check the connector on the fuser for damage or broken pins. If needed replace the fuser.
110V fuser part number: SAM-JC91-01195A
220V fuser part number: SAM-JC91-01194A

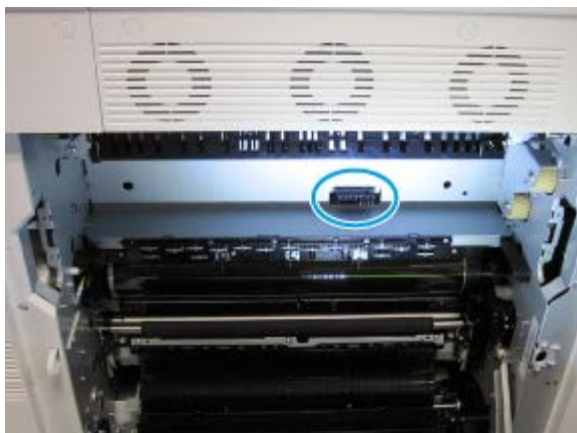
7. Check the connector inside the printer that connects to the fuser. If the connector is damaged, replace the fuser connector assembly.
Part number: TBD

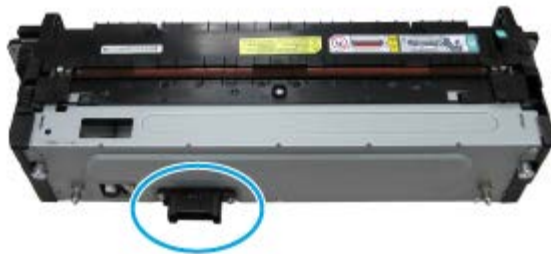
5. Ensure that the printer is not located in front of a vent or window where the cool air might interfere with the ability of the fuser to heat up.
6. Check the connector on the fuser for damage or broken pins. If needed replace the fuser.
110V fuser part number: SAM-JC91-01195A
220V fuser part number: SAM-JC91-01194A

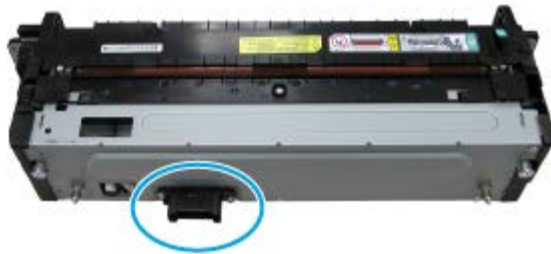
5. Ensure that the printer is not located in front of a vent or window where the cool air might interfere with the ability of the fuser to heat up.
6. Check the connector on the fuser for damage or broken pins. If needed replace the fuser.
110V fuser part number: SAM-JC91-01195A
220V fuser part number: SAM-JC91-01194A

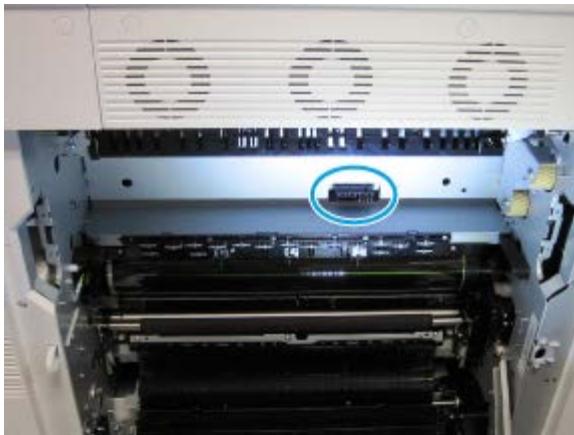
7. Check the connector inside the printer that connects to the fuser. If the connector is damaged, replace the fuser connector assembly.
Part number: TBD

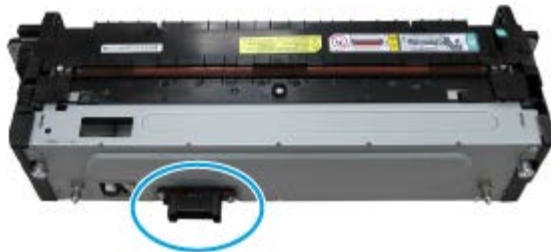
5. Ensure that the printer is not located in front of a vent or window where the cool air might interfere with the ability of the fuser to heat up.
6. Check the connector on the fuser for damage or broken pins. If needed replace the fuser.
110V fuser part number: SAM-JC91-01195A
220V fuser part number: SAM-JC91-01194A

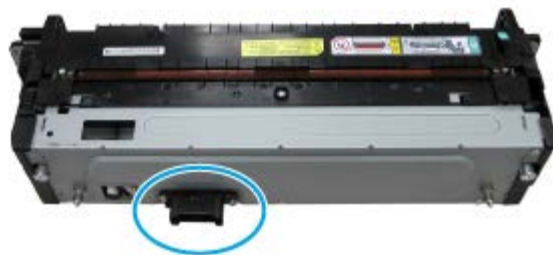
1. Turn the printer off, and then on.
2. Check the fuser.
 - a. Open the right side cover.
 - b. Remove the fuser.
 - c. Check the connector between the fuser and the engine for damage. Replace the fuser as needed.
Part number (110V): SAM-JC91-01195A
Part number (220V): SAM-JC91-01194A

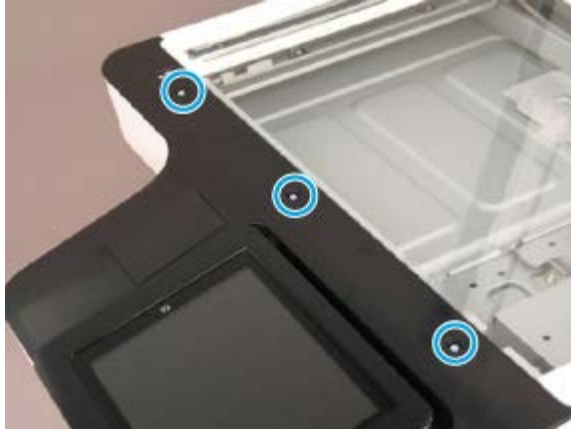
1. Turn the printer off, and then on.
2. Check the temperature sensor.
 - a. Turn the printer off.
 - b. Remove the control panel bezel.
 - i. Open the document feeder, and then remove three screws.

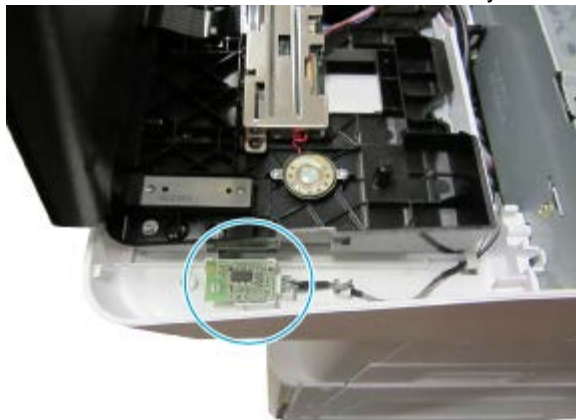
- c. Disconnect and reconnect the connector between the temperature sensor and the main board PCA to ensure the connectors are seated correctly and are not damaged.

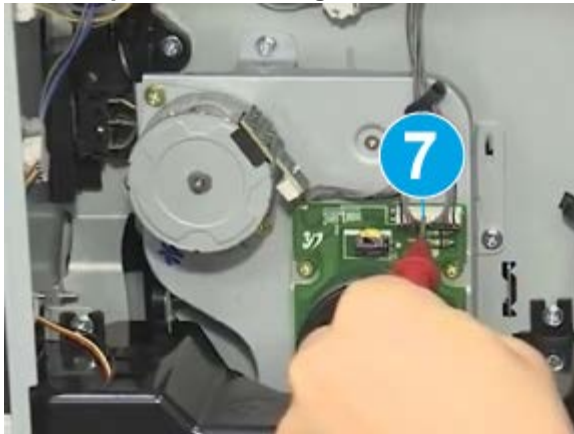
35: Test pin 7 to chassis ground

- ii. If the 24V is abnormal, disconnect the cable and test the voltage on the cable connector from the LVPS. ($24V \pm 5\%$)
 - iii. If the voltage from the LVPS type 5 board is abnormal, replace it.
Part number: (110V) SAM-JC44-00249A
Part number: (220V) SAM-JC44-00250A
 - iv. If the voltage is good from the LVPS but not normal when plugged into connectors, replace the main board PCA.
Part number: SAM-JC92-02922C
 - v. If the voltage is good, continue with checking the signal voltage.
4. Check the motor signal 3.3V from the main board PCA.
- a. Test the motor signal voltage on pin 7 with the motor test running and stopped. The voltage should be $3.3V \pm 5\%$ when running and when 0V stopped.

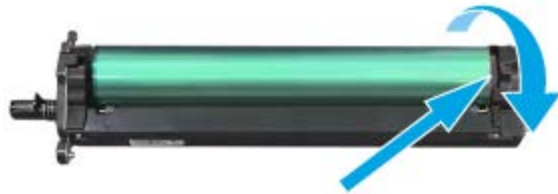
1. Turn the printer off, and then on.
2. If the error persists, check the image drum.
 - a. Open the front and side cover.
 - b. Remove the image drum unit.
 - c. Using your thumb on the gear, ensure that the drum rotates freely. If it does not, replace the image drum.
Part number: X3A74-67902

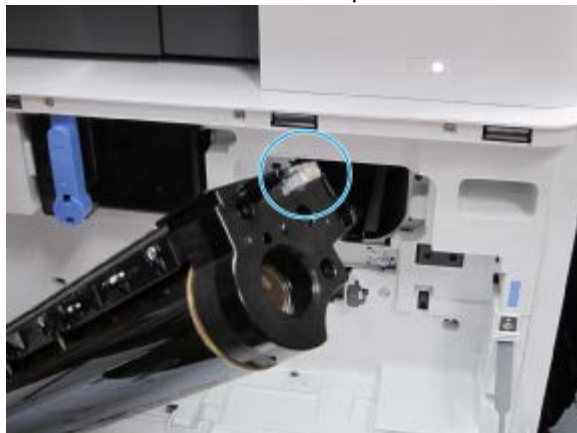
- a. Open the front and right cover.
 - b. Remove the toner collection unit.
 - c. Remove the imaging drum unit and check the CRUM connector for damage. Replace the imaging drum unit as needed.

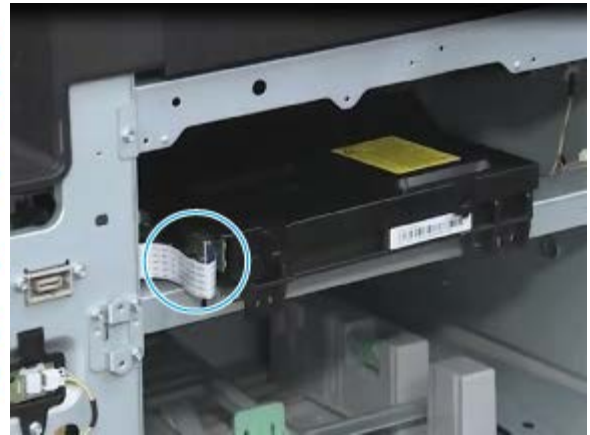
- Service Tools
 - Diagnostics
 - Engine Diagnostics
 - Engine Test Routines
 - b. Run test 110–0000, Laser Scanner Assembly Motor 1 Run Ready
3. If the laser/scanner unit motor does not make a sound, complete these troubleshooting steps:
 - a. Turn the printer off, and remove the power cord.
 - b. Remove the back and the left side covers.
 - c. Disconnect and reconnect the laser/scanner FFC on the laser/scanner and the connector 17 on the main board PCA.

Before unplugging the laser/scanner unit harness, the printer must be turned off and the power cord must be removed.

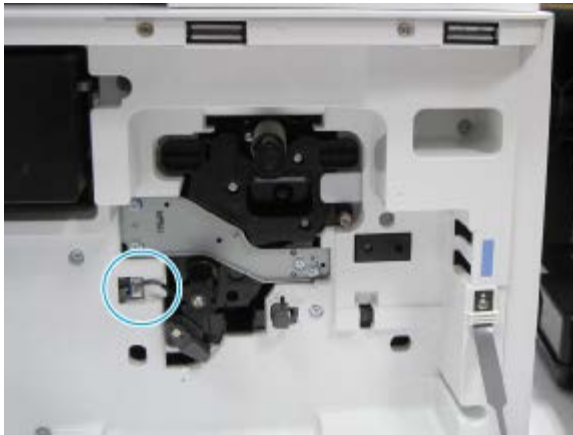
5. Check if the connector of the developer unit is connected correctly.

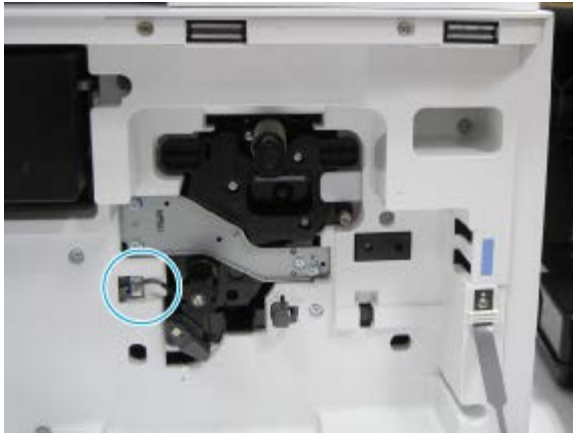
1. Turn the printer off, and then on.
2. Examine the toner supply device to check for any blocked parts.
3. Check the toner supply line from the toner reservoir for any damage or blockage.
4. If there is no problem after checking the sensor connection status, check the sensor output and circuit part.
5. Check if the connector of the developer unit is connected correctly.
